Science and Management Technical Series

Experimental Back-sloping with Vegetation Establishment as an Erosion Control Option for Missouri Streambanks

J. Persinger, K. Grmusich, C. Culler, and B. Jamison

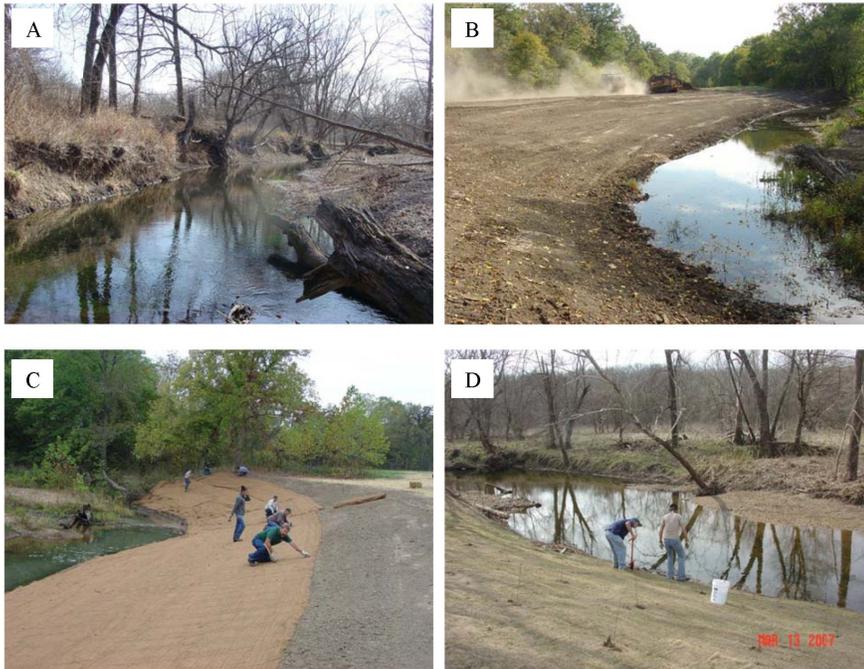
Figure 2. Starks Creek back-sloping site. (A) Prior to project construction February 2006. (B) Sloping the streambank at a 3:1 angle October 2006. (C) Erosion control fabric being stapled to the streambank October 2006. (D) Tree planting March 2007.

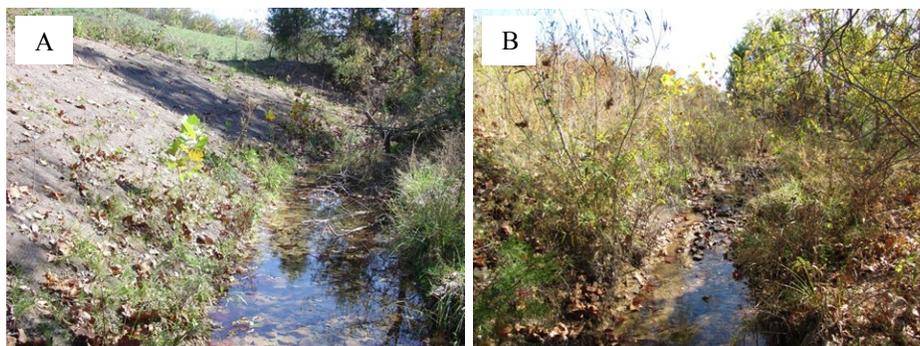
Figure 4. Looking upstream at the California Branch back-sloping project. (A) Post-flow October 2007. (B) Post-flow October 2011.

Photo monitoring demonstrates the effectiveness of this project since project construction in May 2007. The photos show that the sloped streambank has held its slope through its entire length since the project was completed (Figure 4). The pictures also show that while there were areas where vegetation establishment was slow, we now have vegetation established over the entire bank. However, tree establishment has remained slow and this is a concern that could affect the long-term stability of this project because the tree's root systems will be critical to stabilizing the soil of the bank.

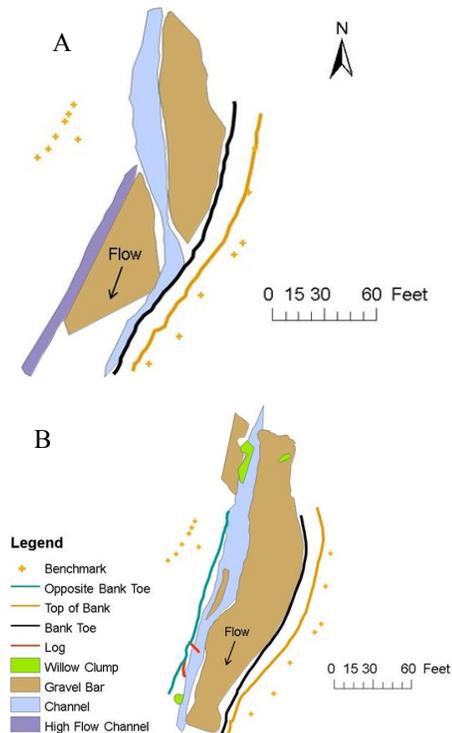
Figure 6. GPS maps of the back-sloping project located on an unnamed tributary on Fiery Fork CA. (A) Post-construction in February 2009. (B) Following channel shift in June 2009.

Photo monitoring illustrates the change in the channel at this location. Photos taken from May 2009 and June 2009 show the dramatic shift in the channel that took place following the first flow event. Photos from 2010 show vegetation establishment and lack of flow near the project streambank (Figure 7). The physical surveys demonstrate how the thalweg shifted away from the streambank following construction

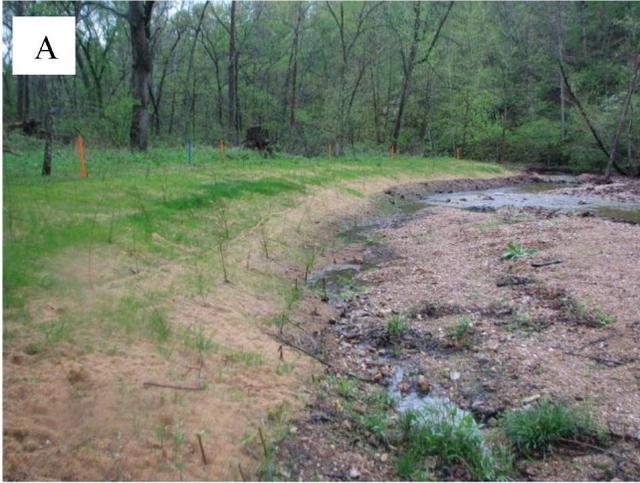
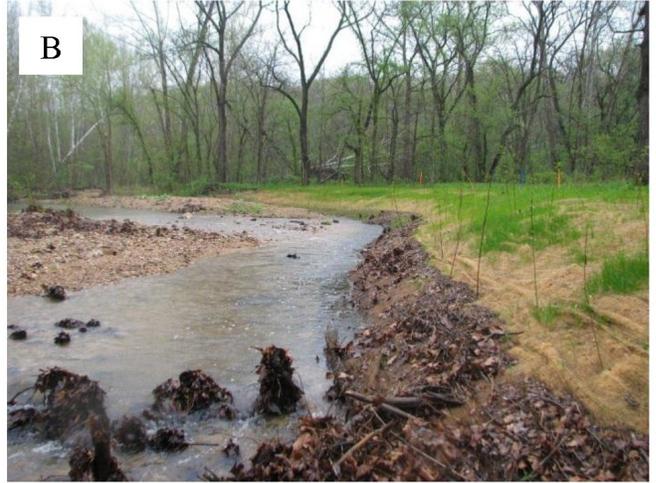
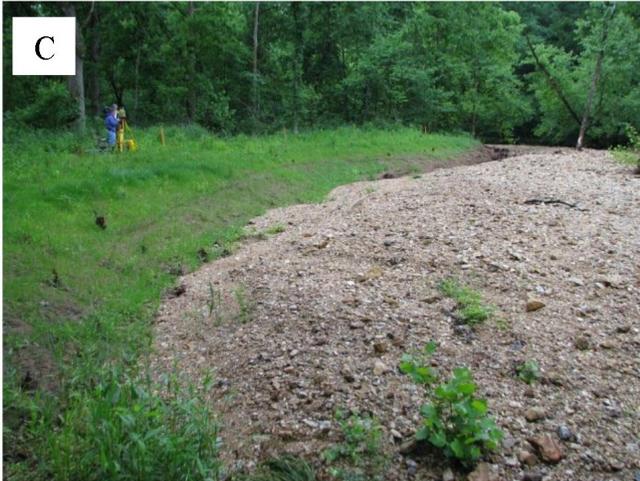
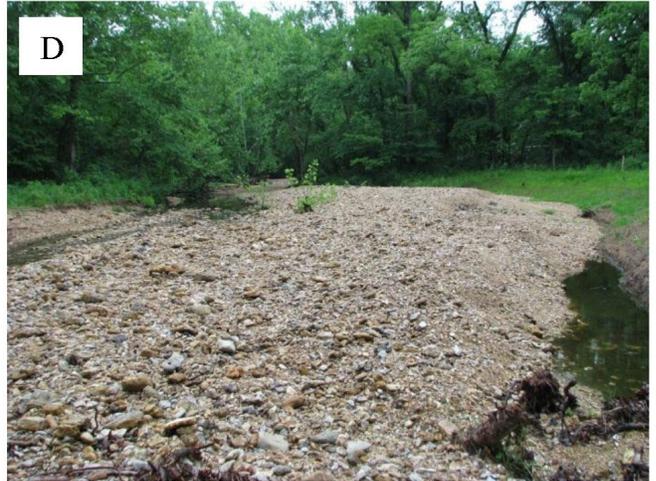
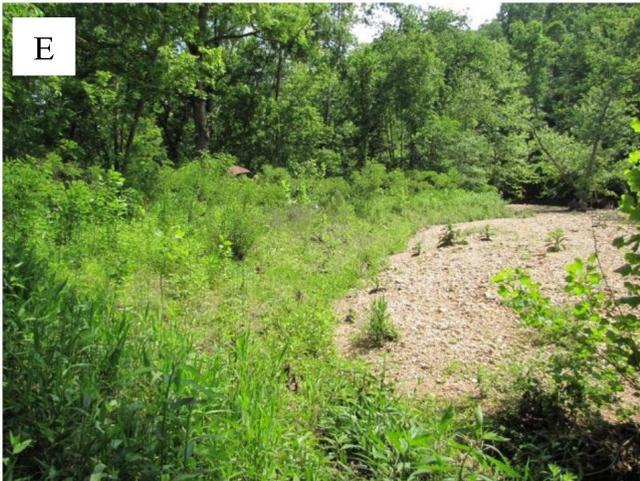
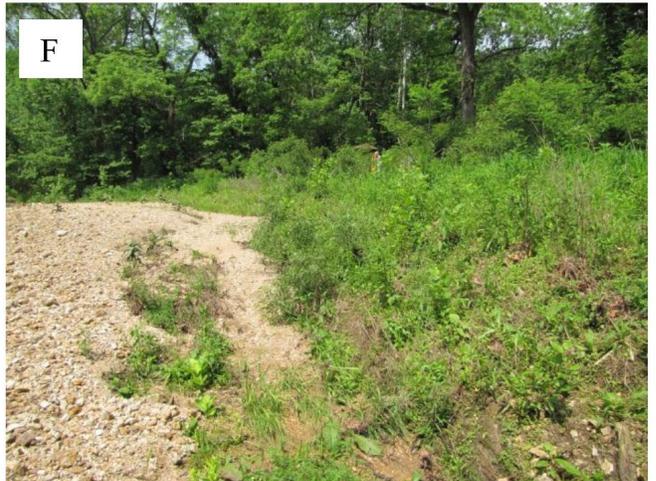
Figure 7. Fiery Fork back-sloping project. (A) Looking downstream May 2009. (B) Looking upstream May 2009. (C) Looking downstream June 2009. (D) Looking upstream June 2009. (E) Looking downstream May 2011. (F) Looking upstream May 2011.

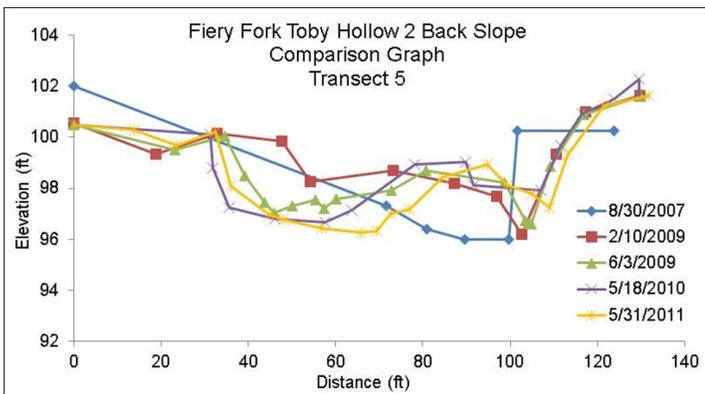
(Figure 8). The shifting of the thalweg away from the streambank resulted in a project that is no longer a good test of the technique.

Figure 8. Physical survey data for transect five for the pre-construction survey (8/30/2007), post-construction survey (2/10/2009), and three post-flow surveys (6/3/2009, 5/18/2010, and 5/31/2011).

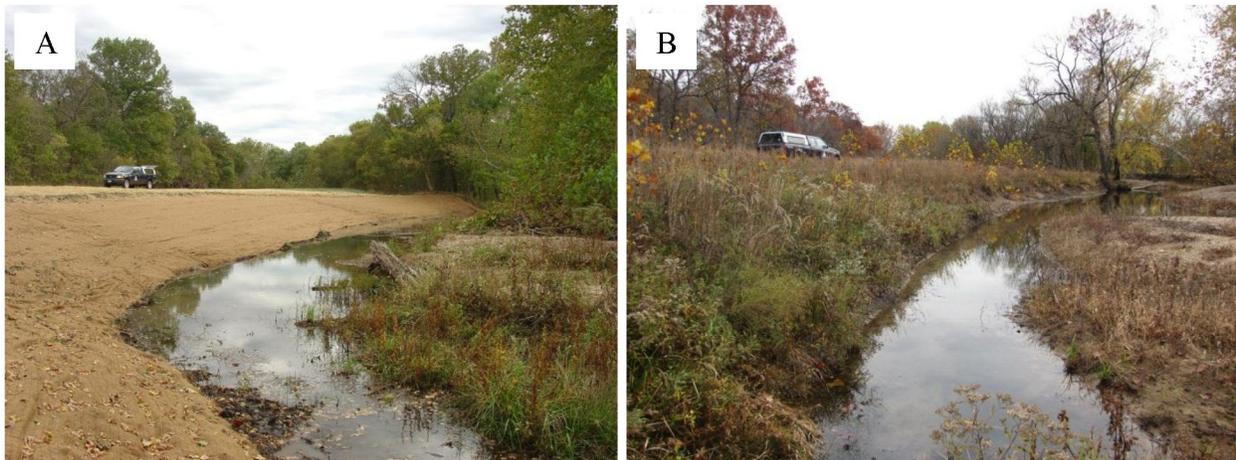
Photo monitoring gives a good visual representation of how the sloped streambank has held up against numerous high flows despite the slow establishment of vegetation and changes in the stream morphology above the project (Figure 11). The channel cut through the upstream streambank and gravel bar and now approaches the project from further downstream than it did before. The change in the stream's approach to the project contributed to erosion at the lower end, but has not resulted in a significant increase in streambank slope. Details on streambank movement along each transect are shown below

(Table 3). Even though there has been some erosion at the streambank toe (particularly transects two, four, five, and six) the slope of the streambank has remained relatively stable. The toe erosion that has occurred has prevented vegetation establishment on that portion of the streambank and has made this project vulnerable to further erosion and potentially failure.

Figure 11. Photos of the Starks Creek back-sloping project. (A) Looking downstream at the project following construction in October 2006. (B) Looking downstream at the project in October 2011.

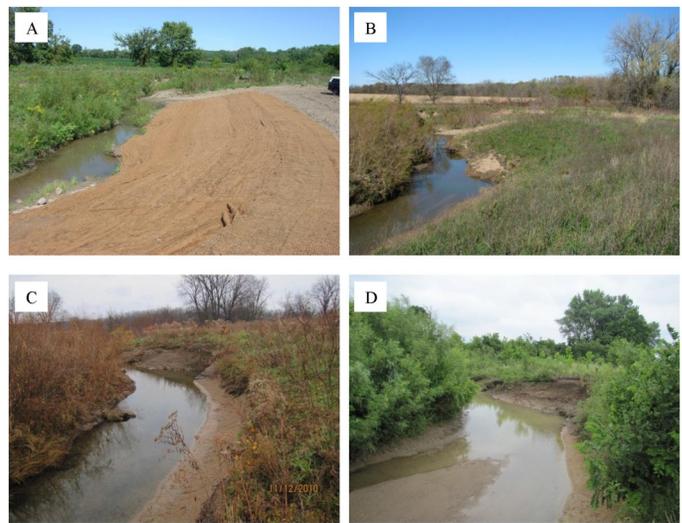
photo monitoring, which has occurred on multiple occasions since project construction in August 2007, gives a good visual representation that while the sloped streambank has held through most of its length, a large area of erosion has begun to develop in the

lower half of the project (Figure 13).

The physical surveys, which were conducted post-construction and following flow events each year from 2008-2011, give details on streambank movement along each transect throughout the entire length of the project (Table 4). Transect six gives a good example of the large amount of toe erosion that has occurred since project construction (Figure 14). Erosion has occurred at the streambank toe along six of the eight transects, particularly transects four, five, six and seven, which are located from the apex of the bend through the downstream end of the project. This erosion has resulted in the failure of the project, despite

Figure 13. Looking downstream at Union Ridge East back-sloping project. (A) Post-construction September 2007. (B) Post-flow October 2008. (C) Post-flow November 2010. (D) Post-flow July 2011.

the fact that the overall slope of the streambank has remained relatively stable. The overall size of the streambank has masked the toe erosion that has occurred and prevented any large change in the overall streambank slope. The slope at the toe itself did increase dramatically.

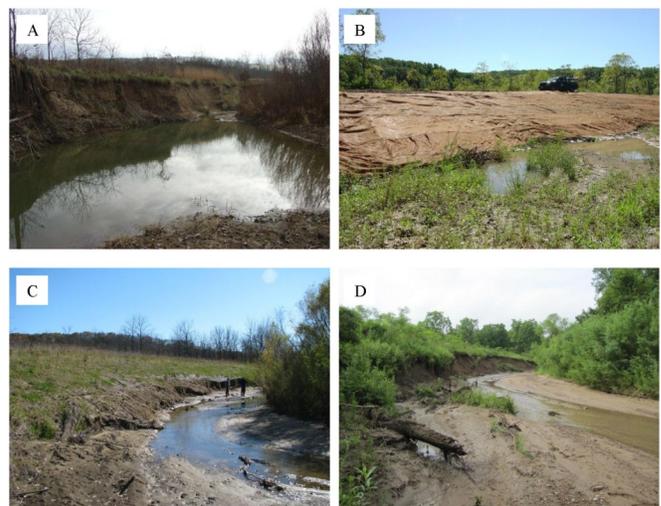
Figure 15. Looking upstream at the back-sloping project on the Union Ridge west tributary of Spring Creek. (A) Pre-construction November 2005. (B) Post-construction September 2007. (C) Project October 2008. (D) Project July 2011.

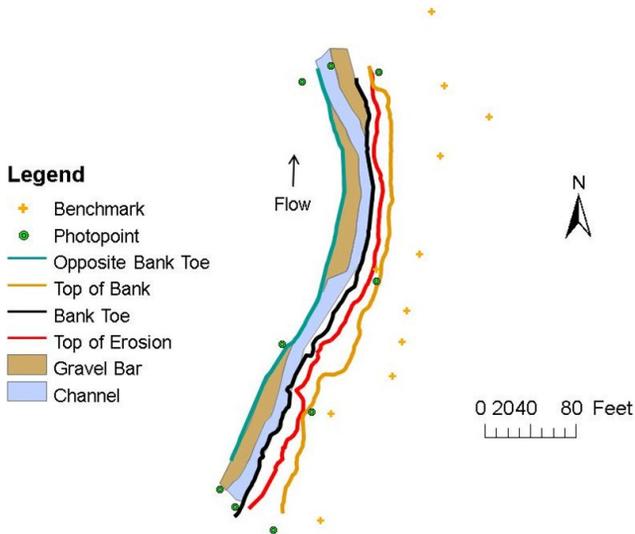
GPS mapping and the physical survey data illustrate the extent of the erosion. The largest areas of toe erosion can be seen on the GPS map (Figure 16).

Figure 16. GPS map of the back-sloping project located on the unnamed west tributary of Spring Creek on Union Ridge CA.

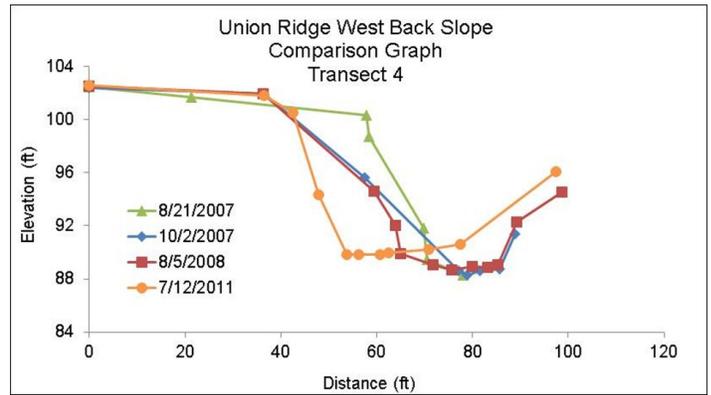
The Union Ridge West project appears to have failed despite the sloping, because the erosion control fabric was not strong enough and the vegetation was not yet well enough established to protect the streambank toe from erosion during high flows. The streambank has eroded more than 15 ft. at seven of the nine transects and four of those have eroded more than 20 ft. (Table 5). Despite the large amount of erosion that has been seen at this site, there has been little change in overall streambank slope between the post-construction and final post-flow survey. The overall size of the streambank has masked the toe erosion that has occurred and prevented any large change in the overall streambank slope. The slope at the toe itself did increase dramatically and can be seen by looking at the transect graphs (Figure 17).

Figure 17. Physical survey data for transect four for the pre-construction survey (8/21/2007), post-construction survey (10/2/2007), and two post-flow surveys (8/5/2008 and 7/12/2011).
