*Science and Management Technical Series  
Number 7*

# Experimental Log Weirs as an Erosion Control Option for Missouri Streambanks

J. Persinger, K. Grmusich, C. Culler, and B. Jamison

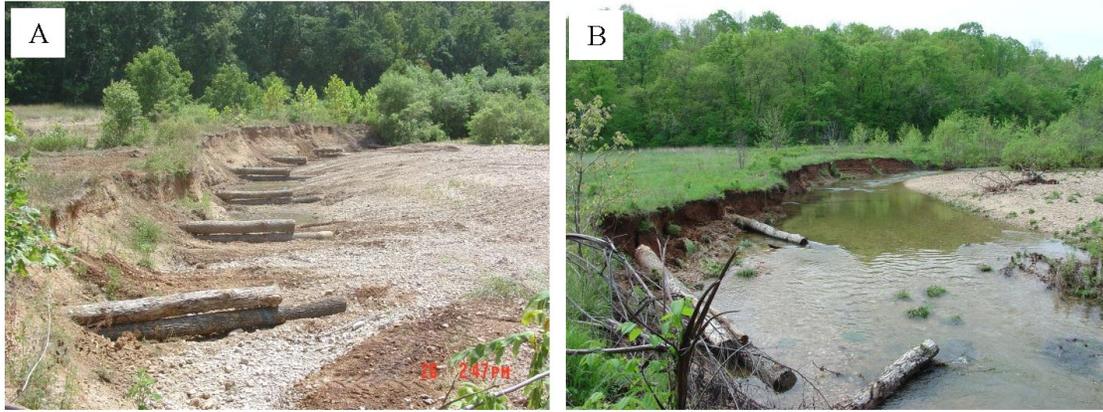
Photo points show how the weirs shifted and the resulting erosion that occurred at the lower end of the project (Figure 3). Weirs five, six, and seven all failed completely and weir four was a partial failure

(Table 2). Weir three held, but had some erosion of the key. Only weirs one, two, and eight showed no substantial changes after the flow event. Because the weirs shifted position and were no longer at an angle that directed flow away from the streambank and were instead at an angle that directed flow towards the streambank, they caused a large amount of erosion between the weirs. The survey data documented the streambank erosion that occurred (Table 3). The largest erosion occurred on transects four through eight.

Figure 3. Jakes Creek log weir project. (A) Post-construction looking upstream July 2005. (B) Post-failure looking upstream April 2006.

GPS maps created in August 2005 (after initial construction) and May 2006 (after failure) illustrate the relative changes that occurred throughout the site due to the flow event (Figure 4). To address future erosion at this site the decision was made to remove the project and replace it with a different type of project. The project failed because the keys (the area where the logs were buried in the streambank) were not strong enough to hold the logs in place during high flow events. As a result all future log weir projects were modified to strengthen the keys by ensuring that at least half the length of the log was buried in the streambank and by adding large shot rock to the keys

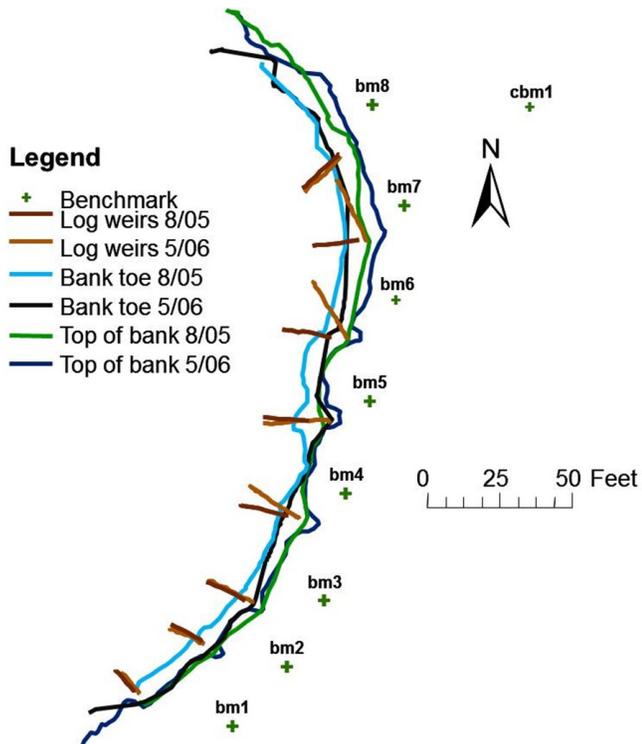
Figure 4. GPS map of the Jakes Creek log weir project showing the position of the weirs, top of the bank, and toe of the streambank post-construction (August 2005) and post project failure (May 2006).

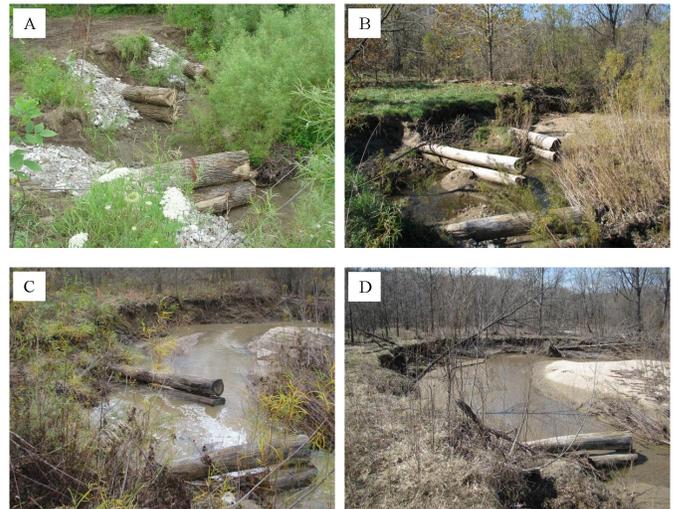
The flow events that occurred in 2009 continued the erosion process that had started at the base of weir five in 2008. The 2009 flows caused the failure of weir six with the logs being completely washed away. The 2010 flow events resulted in continued erosion at the lower end of the project, and weir five was completely washed away. Photo monitoring shows extensive erosion between weirs four and five and at the base of weir five in 2008. In 2009, the erosion shifted downstream to the streambank between weirs five and six and caused the failure of weir six. In 2010, weir five was completely washed away and there was extensive erosion downstream of weir four even though upstream of weir four the project has protected the streambank (Figure 6). The cause for this failure and the erosion is the design of the project. The spacing between weirs four and five was too far given the tight curvature of the bend. Flow coming off weir four was not redirected enough to hit weir five in the correct place, resulting in a large amount of erosion at the base of weir five and the eventual complete failure of weirs five and six.

Figure 6. Dry Branch log weir project. Looking downstream at weirs four, five, & six. (A) Post-construction July 2006. (B) Post-flow October 2008. (C) Post-flow October 2009. (D) Post-flow March 2011.

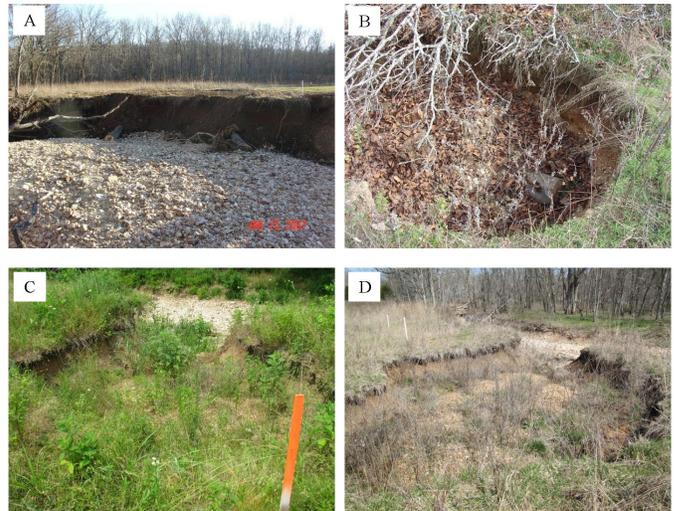
the key of weir three (Figure 8). The washouts appeared to be a result of burying shot rock in the key material instead of using it to protect the surface of the replaced key material as was done at all the other projects. Mill Creek was the only project where this was done and the only place we saw key erosion in this form. Photos show the large area of erosion associated with the weir four key (Figure 9).

Figure 9. Mill Creek log weir project. (A) Looking at weirs four and five following construction January 2007. (B) Looking at weir four key November 2007. (C) Looking at weir four key June 2009. (D) Looking at weir four key March 2011.

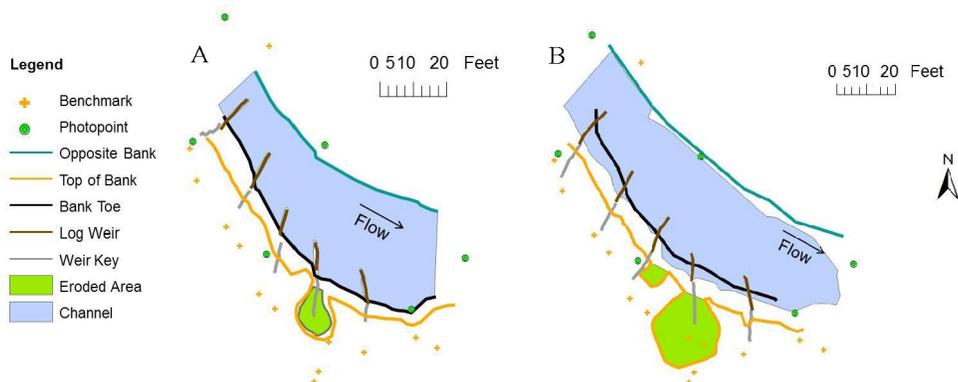
der the top of the streambank. This flow event caused the key of weir four to be damaged (Figure 8). The washout of the key of weir four could have led to the eventual failure of the project; however, additional flow events in 2008 did not cause any more damage. In fact, the key area appeared to receive deposition during the 2008 flows. Unfortunately, the size of the spring 2008 events is unknown because the Levelogger® was lost and not replaced until July of 2008. In 2009, there were no high flow events recorded. In 2010, a single high flow event increased the size of the washout at weir four and started a small washout at

Figure 8. GPS map of Mill Creek log weir project (A) following first flow event in the summer of 2008 and (B) following high flow event in spring of 2010.

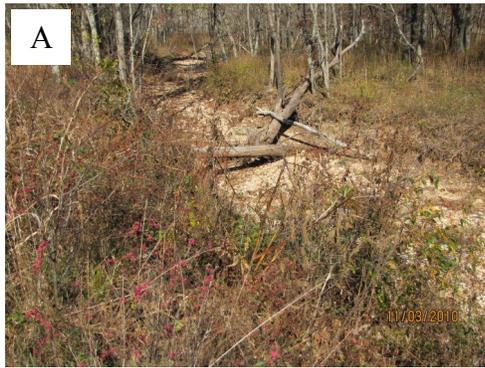
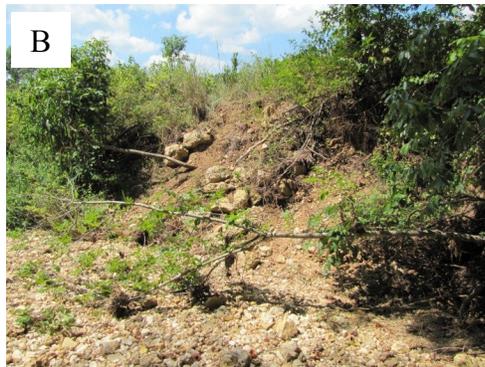
weir one. During the 2011 flow event, pressure exerted on the two logs and potentially other logs moving through the system resulted in log weir one breaking at the streambank (Figure 10). Additional logs are suspected to be involved because a log jam formed just downstream of the project following this flow event. A head-cut that moved through the system and is still active less than ½ a mile upstream of the project is the source of the woody debris moving through the system.

Figure 10. Mill Creek log weir project. (A) Looking upstream at weir one October 2010. (B) Looking at weir one's key following the log breaking off at the streambank July 2011.

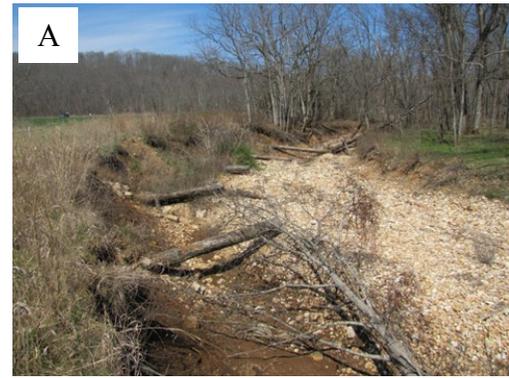
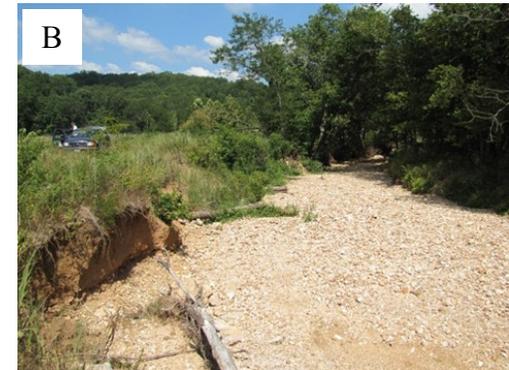
Figure 11. Mill Creek log weir project. (A) Looking upstream at the project March 2011. (B) Looking upstream at the project following the failure of weir five July 2011.

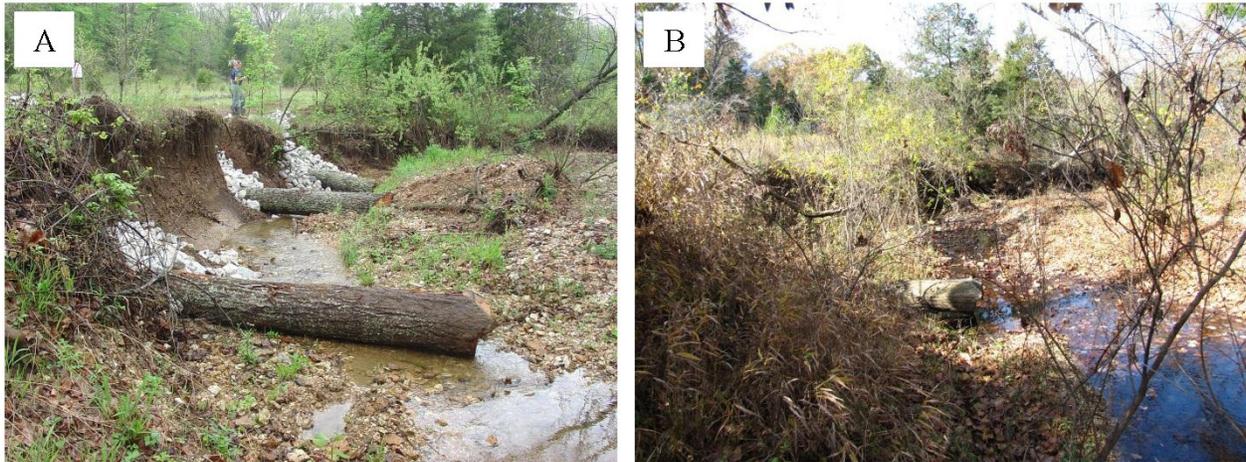
Figure 13. California Branch site 3 log weir project. (A) Looking downstream at project post-construction May 2007. (B) Looking downstream at the project October 2011.

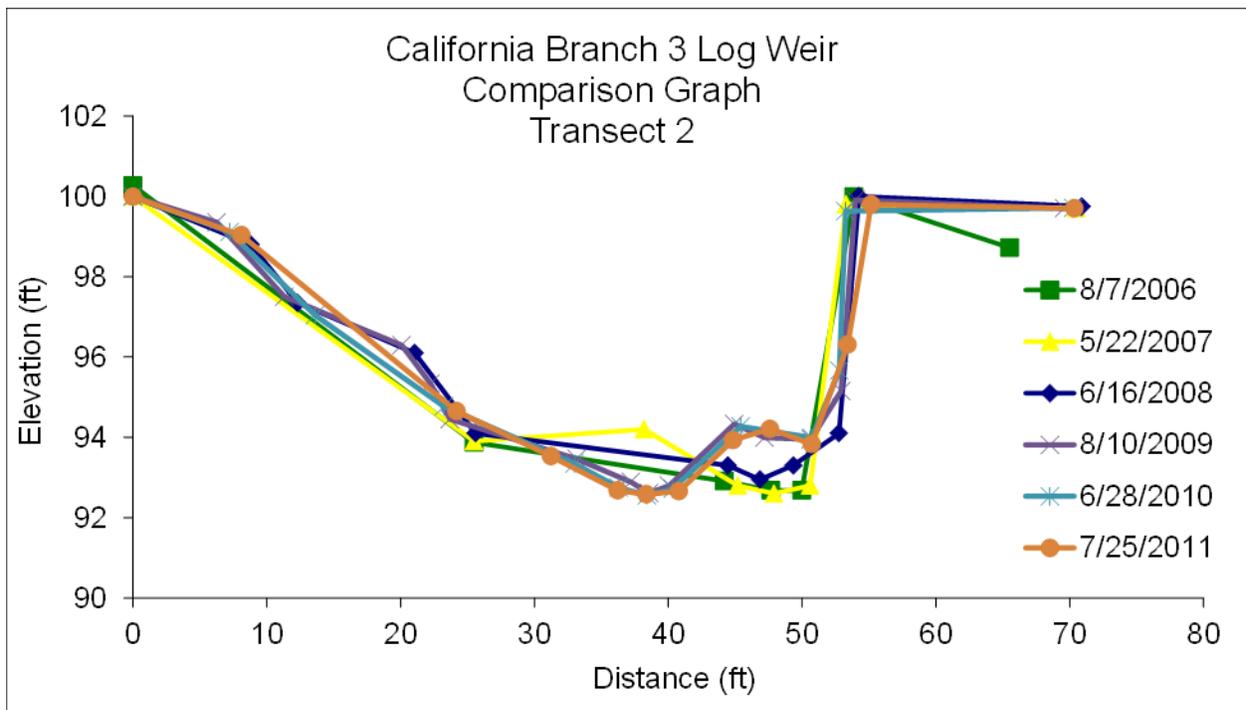
Following the flow events the thalweg has moved away from the streambank along the entire length of the project and deposition occurred between the weirs. Transect two gives a good illustration of the deposition of material at the streambank toe and the shifting of the thalweg away from the streambank

that occurred (Figure 14). The channel shift occurred along the entire length of the project (Figure 15). The thalweg has moved away from the toe, streambank slope is decreasing, deposition has occurred, and vegetation is beginning to establish (Table 6). These trends indicate the project has a good chance of working long-term. Although the streambank has become

Figure 14. Physical survey data for transect two for the pre-construction survey (8/7/2006), post-construction survey (5/22/2007), and four post-flow surveys (6/16/2008, 8/10/2009, 6/28/2010, and 7/25/2011).

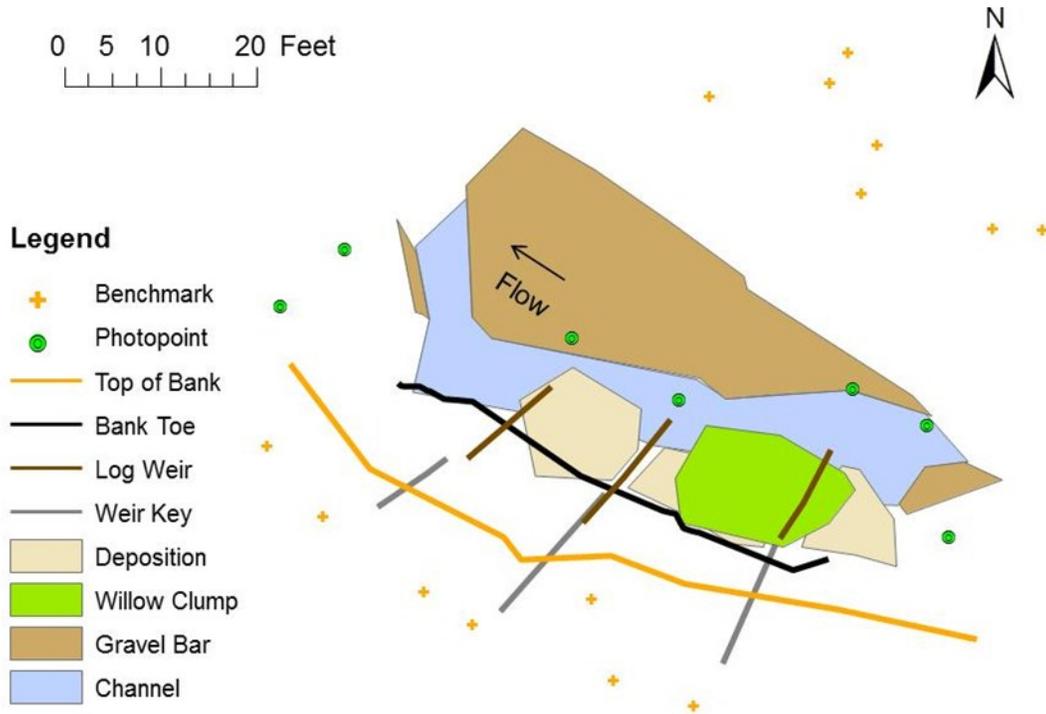
Figure 15. GPS map of the California Branch site 3 log weir project in July 2011.

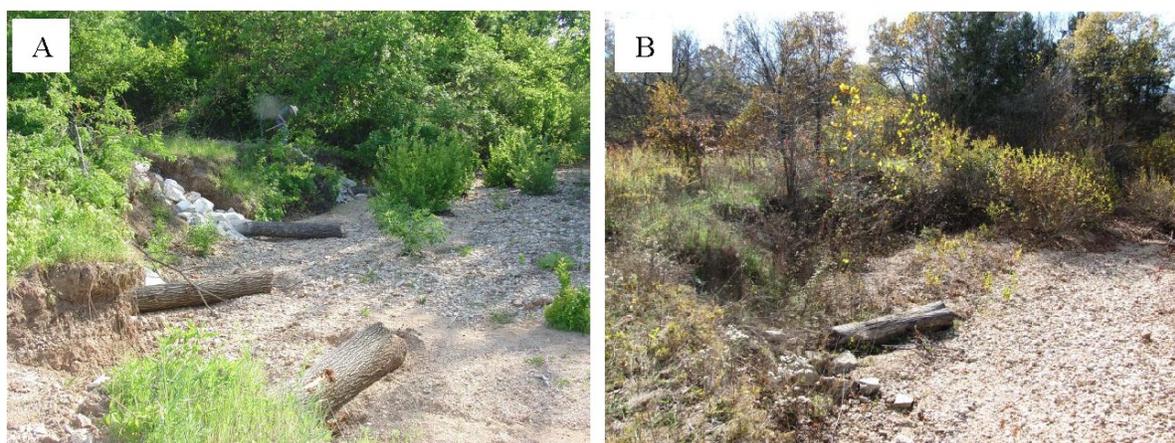
Figure 17. California Branch log weir project. (A) Looking upstream at project post-construction May 2007. (B) Looking upstream at the project October 2011.

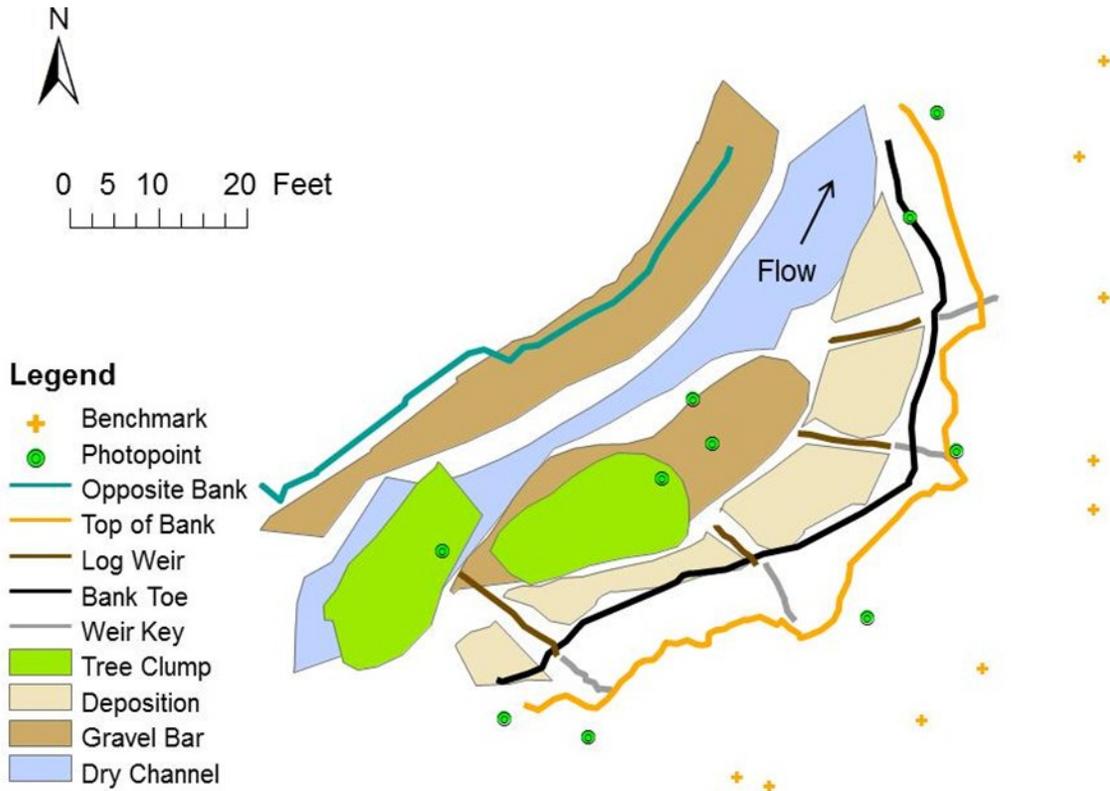
Figure 18. GPS map of the downstream California Branch log weir project in June 2010.

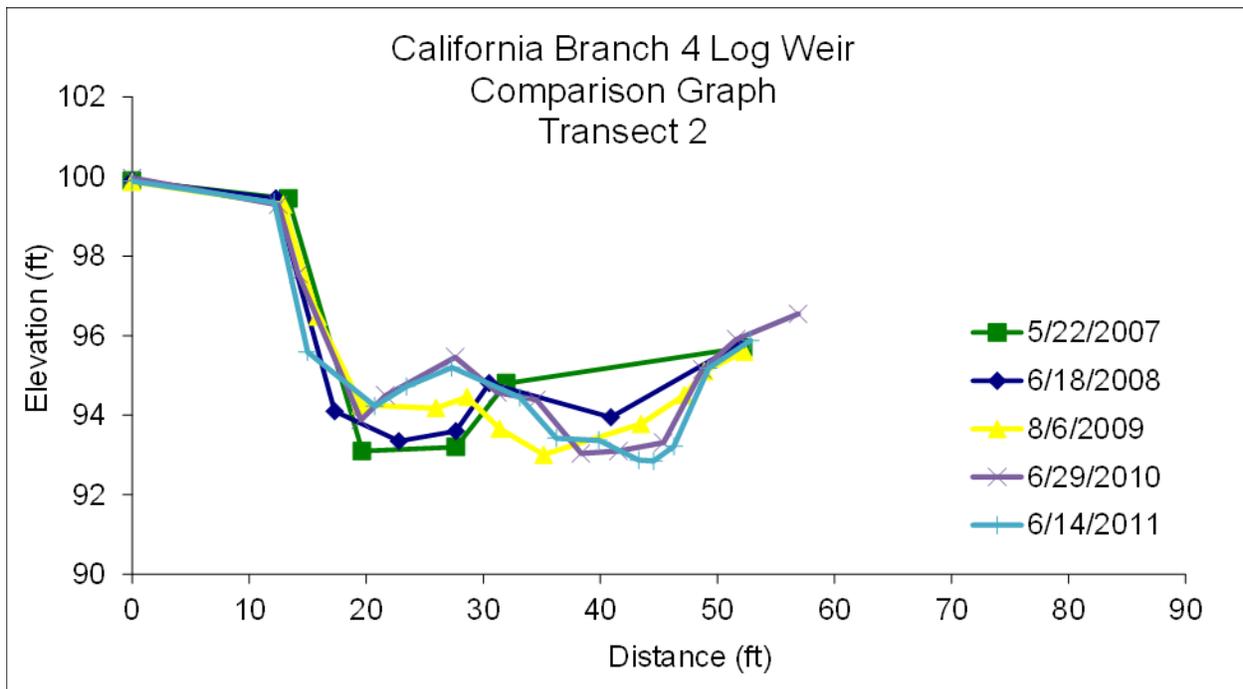
Figure 19. Physical survey data for transect two for the post-construction survey (5/22/07) and four post-flow surveys (6/18/2008, 8/6/2009, 6/29/2010, and 6/14/2011).
