Drainage Ditch Profile Map

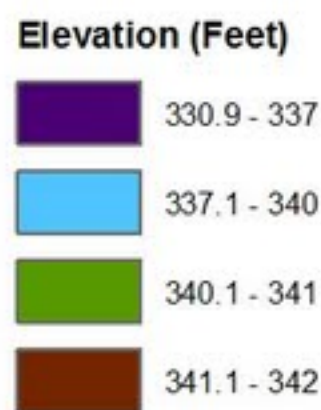
Without Modifications:

- Lowest landscape position remained wet
- Poorly drained, water table close to surface
- Precipitation would collect at low elevations and spread out to higher elevations

With Ditch and Spoil Piles:

- Ditch cuts across lowest elevation,
- Water table was lowered, which also had lateral effects drying surrounding area
- Precipitation was diverted by the ditch or blocked by the spoil pile

With Ditch, Roads, Borrow, Spoil Piles, and Boat-lanes:

- Ditch cuts across lowest elevation,
- Water table is lowered by ditch, which also has lateral effects drying surrounding area
- Water held in pool or borrows partially raises the immediate water table
- Precipitation is diverted by the ditch or blocked by the spoil pile and the road
