Science and Management Technical Series

Experimental Back-sloping with Vegetation Establishment as an Erosion Control Option for Missouri Streambanks

J. Persinger, K. Grmusich, C. Culler, and B. Jamison

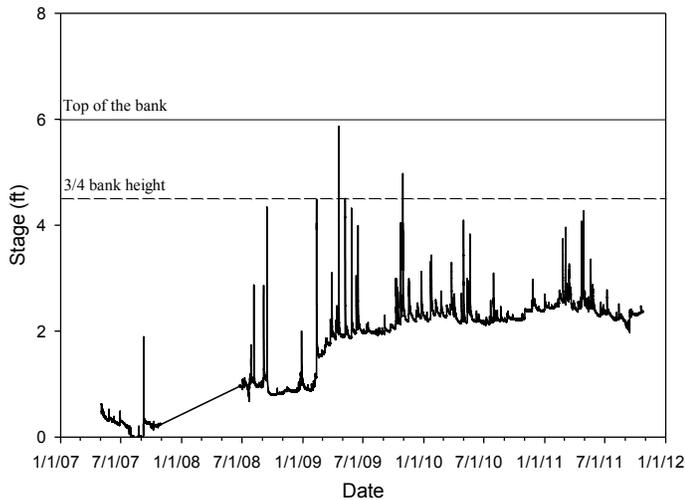
Figure 3. Levellogger® data from California Branch for 2007 through 2011. Data are missing from November 2007 until June 2008 due to a lost Levellogger®.

Since construction, the California Branch project has been tested by only a few flow events greater than $\frac{3}{4}$ of the streambank height (4.5 ft., Figure 3). Following construction, the project was not tested by any flow events during the rest of 2007. In the spring of 2008, the project was tested by at least one and potentially multiple flow events that reached a stage of $\frac{3}{4}$ of the streambank height or higher. Unfortunately, the number and size of flow events are unknown because during a high flow event the Levellogger® was lost

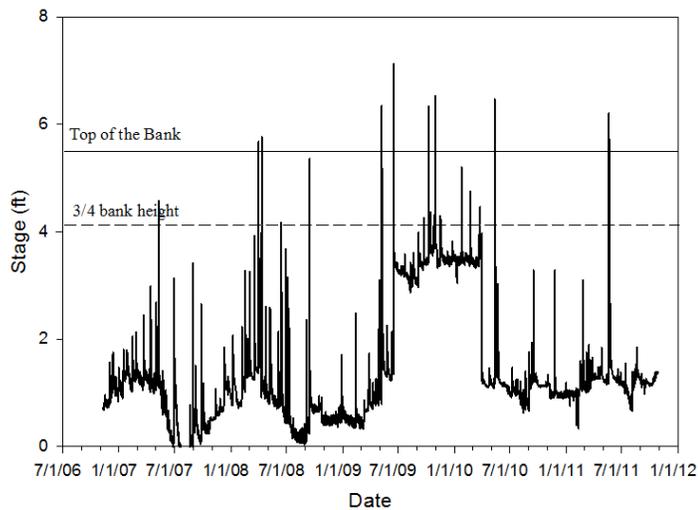
Figure 5. Levellogger® data from an unnamed tributary of Fiery Fork Creek for 2006 through 2011.

been tested by multiple high flow events (Figure 5). Immediately following placement of the fabric, a small flow event reaching $\frac{1}{2}$ the streambank height tested the project. No fabric was relocated nor any change in streambank stability noted even though no vegetation had been established on the bank. In May of 2009, a flow event went over the top of the streambank and caused the failure of the farm rock toe project located upstream and caused major changes to the channel (Figure 6). The flow event caused a shift in the thalweg at this site. The thalweg switched from running directly against the toe of the streambank to a previous high flow area behind the opposite gravel bar. An even larger flow event in June 2009 and two additional high flow events that occurred in September of 2009 helped lock the stream in its new configuration. By 2010 the flow was well established in the new location and additional flow events in 2010 and 2011 did not make any significant changes.

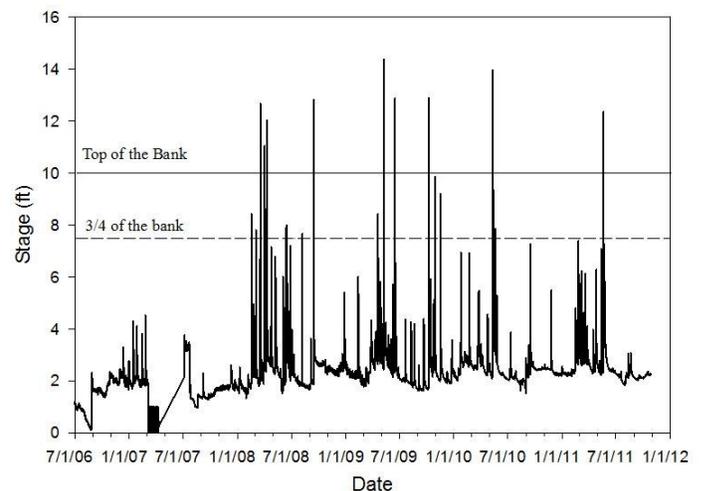
Figure 9. Levellogger® data from Starks Creek for 2006 through 2011. Data are missing from March 2007 until July 2007 due to a Levellogger® malfunction.

The Starks Creek project has been tested by numerous flows that went over the top of the eroding streambank since construction (Figure 9). In addition to the flows shown on the graph, there were at least two flow events between April and June 2007 that were not recorded because of a malfunction with the Levellogger® in late March that was not detected until July. During 2008, the project was tested by 10 flow events greater than $\frac{3}{4}$ of the height of the streambank (7.5 ft.) and five more flow events greater than the top of the streambank (10 ft.). Three of the five flow events that went over the streambank topped out at a stage greater than 12 ft. All three represented a 10 ft. rise over the average stage during the previous week. The first of these flow events caused the failure of the gravel roll with back-sloping project that was located immediately upstream and caused a change in how the stream approached the back-slope project (Figure 10).

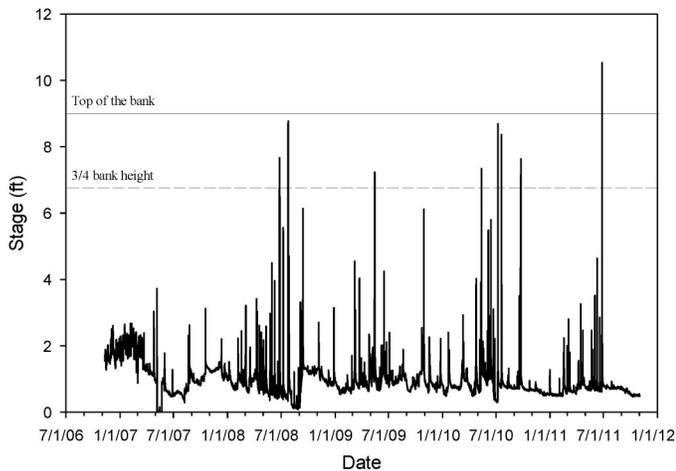
Figure 12. Levellogger® data from an unnamed east tributary of Spring Creek for 2006 through 2011.

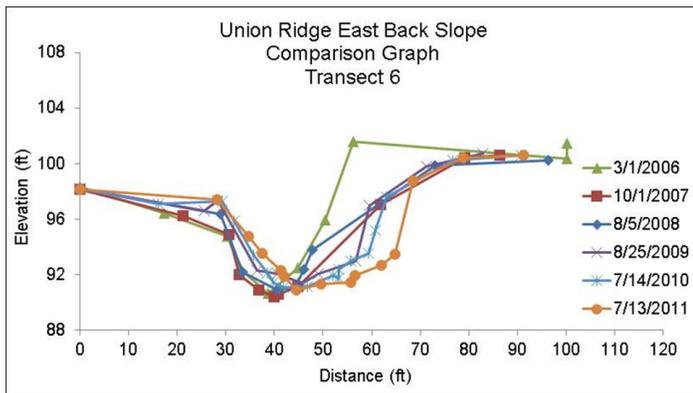
The physical surveys, which were conducted post-construction and following flow events each year from 2008-2011, give details on streambank movement along each transect throughout the entire length of the project (Table 4). Transect six gives a good example of the large amount of toe erosion that has occurred since project construction (Figure 14). Erosion has occurred at the streambank toe along six of the eight transects, particularly transects four, five, six and seven, which are located from the apex of the bend through the downstream end of the project. This erosion has resulted in the failure of the project, despite

Figure 14. Physical survey data for transect six for the pre-construction survey (3/1/2006), post-construction survey (10/1/2007), and four post-flow surveys (8/5/2008, 8/25/2009, 7/14/2010, and 7/13/2011).
