*Science and Management Technical Series  
Number 7*

# Experimental Log Weirs as an Erosion Control Option for Missouri Streambanks

J. Persinger, K. Grmusich, C. Culler, and B. Jamison

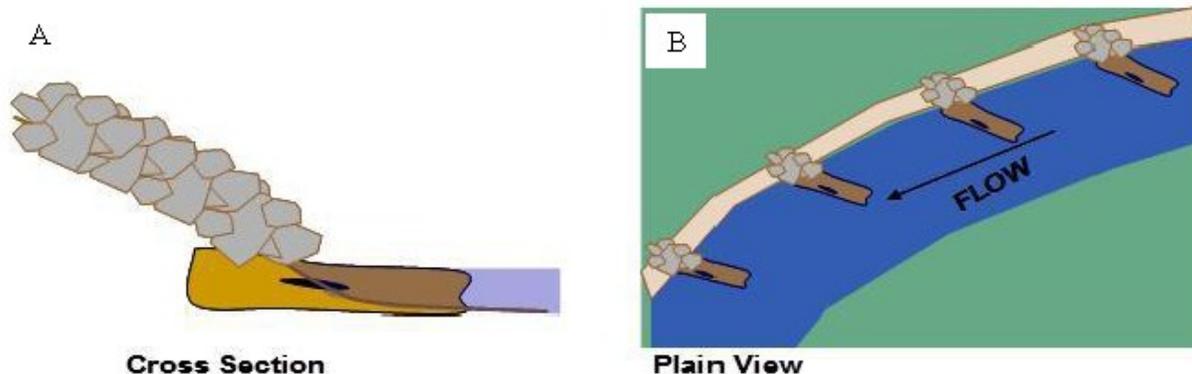
Figure 1. (A) Cross section and (B) plain view of a generic experimental log weir project.

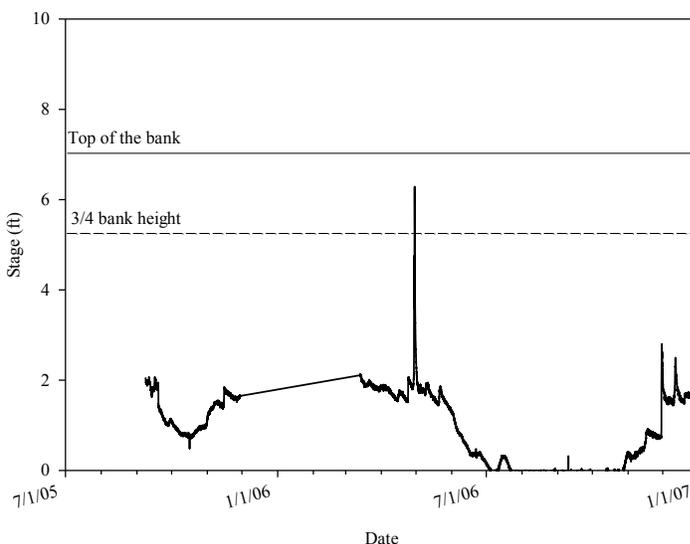
The Jakes Creek project did not use rock to protect the key and instead just had the material that was removed to dig the key trench packed back into the trench to hold the logs in place. Prior to any of the other log weir projects being built, a high-flow event occurred on Jakes Creek on April 29-30, 2006 following an approximately 3 inch rain event. The rain event brought the stage to a height of 6.29 ft. (Figure 2), which represented a 4.5 ft. rise over the average flow during the previous week. The stage height represents a flow just under the top of the eroding bank. This high flow event caused extensive damage to the project which resulted in its failure.

Figure 2. Levelogger® data for Jakes Creek from 2005 through 2006.

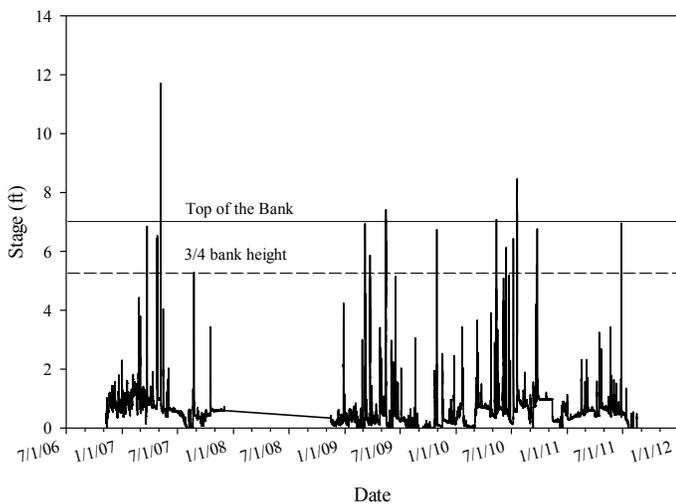
Dry Branch was constructed using the lessons learned at Jakes Creek. Dry Branch was the first project to use shot rock to protect the weir keys and bury at least ½ of each log in the key. The project has experienced a large number of high flow events (Figure 5).

In the spring of 2007, the project withstood two high flow events between  $\frac{3}{4}$  the height of the streambank and the top of the streambank and one flow that went over the top of the streambank. The largest flow event caused the failure of a shot rock weir project located approximately a  $\frac{1}{4}$  mile upstream. Although some of the rock protecting the keys of the log weir project did get washed away, the streambank survived without damage. Additional flow events in 2008 caused the project to be eroded between weirs four and five. Unfortunately, the size of these events is unknown because the Levellogger® was lost and not replaced until June of 2008. Additional flow events in late summer and early fall of 2008 were also not recorded because a second logger was lost and not replaced until November of 2008. In 2009, Dry Branch had three flow events that reached a stage above  $\frac{3}{4}$  of the streambank height and a fourth that went over the top of the streambank. In 2010, the project was tested by three flow events that went over the top of the streambank and three other events that were greater than  $\frac{3}{4}$  of the streambank height. In 2011, there was a single flow event that reached a height equal to the top of the

Figure 5. Levelogger® data from Dry Branch for 2006 through 2011. Data are missing from December 2007 until November 2008 due to the loss of two Levelogger®s.

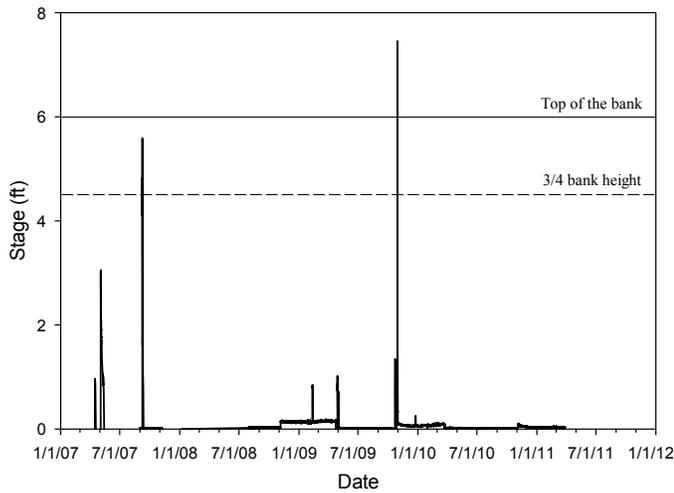
The Mill Creek project also incorporated the lessons learned at Jakes Creek. Shot rock was used to protect the weir keys and at least ½ of each log was buried in the key. Mill Creek is a losing stream in the reach where this project was built, and therefore only has flow immediately following rain events. The first flow event to test the project occurred in September 2007 (Figure 7). During this event, the stream went from no flow to a stage of 5.5 ft., which is slightly un-

Figure 7. Levellogger® data from Mill Creek for 2007 through 2011. Data are missing from November 2007 until July 2008 and after March 2011 due to the loss of multiple Levellogger®s.

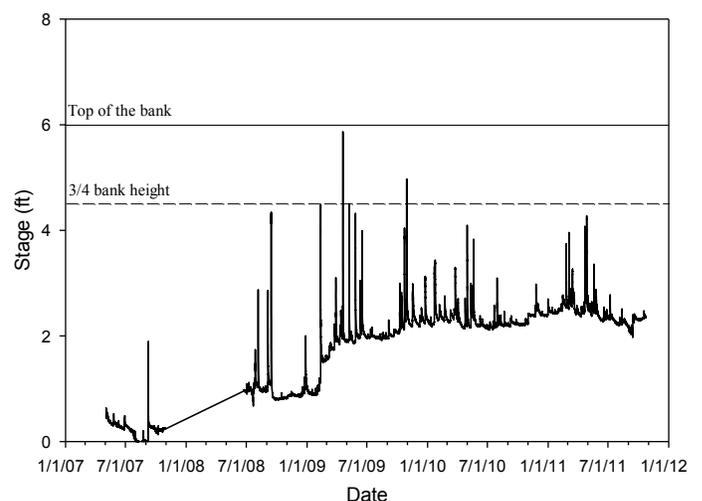
protect the weir keys and at least ½ of each log was buried in the key. The project was only tested by a limited number of flow events in 2008 and 2009 (Figure 12). Following construction in the spring of 2007, the project was not tested by any flow events

Figure 12. Levellogger® data from the upstream portion of California Branch where site 3 is located for 2007 through 2011. Data are missing from October 2007 until June 2008 due to a lost Levellogger®.

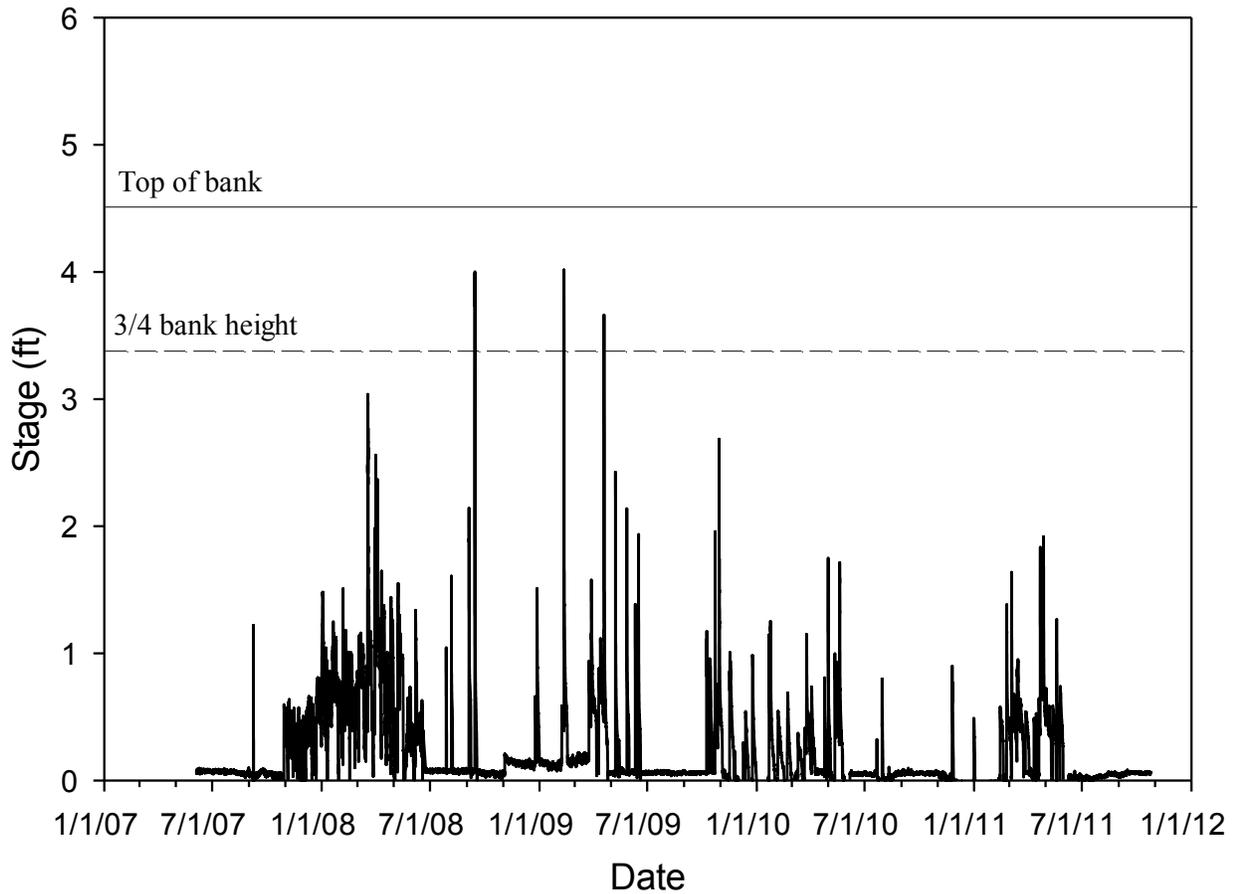
California Branch Site 4, which incorporated what we learned at Jakes Creek into its design, was only tested by a small number of flow events in 2007 - 2011 (Figure 16). Following construction in the spring of 2007, the project was not tested by any flow events during the remainder of the year. In September 2008, there was a single flow event that reached a stage above  $\frac{3}{4}$  of the streambank height. In 2009, the project was tested by two additional flow events that were greater than  $\frac{3}{4}$  of the streambank height. In 2010 and 2011, there were no large flow events.

Figure 16. Levellogger® data from the downstream portion of California Branch where site 4 is located for 2007 through 2011.
