# ***STREAM HABITAT***

## **Instream Habitat Assessment**

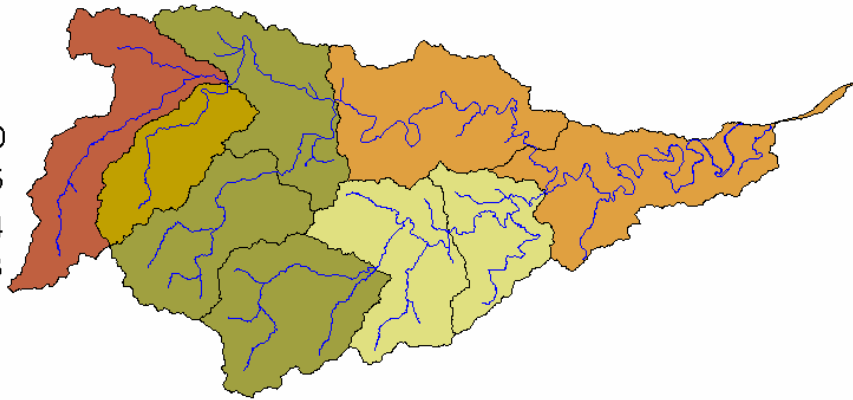
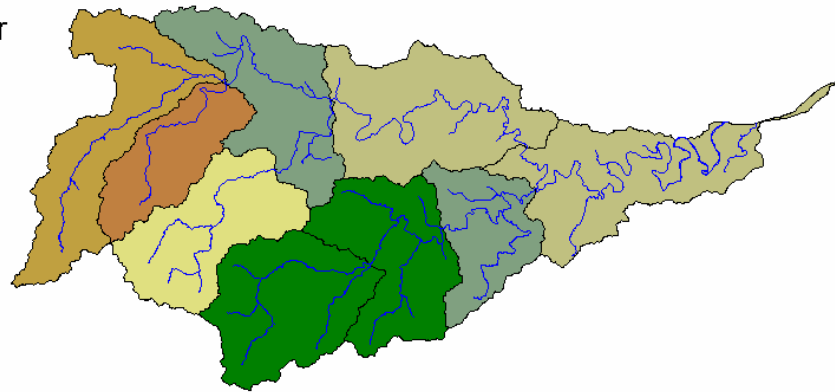
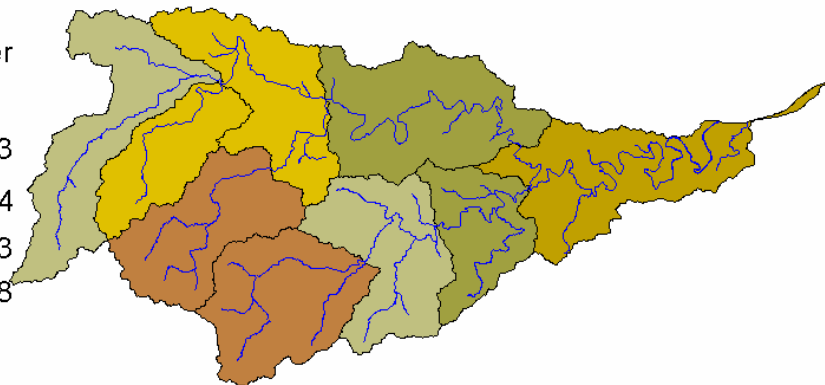
Percent of Forest Cover

Percent of Cropland Cover

Percent of Grassland Cover

Figure sf2. Riparian 90-foot wide land use in the Moreau River sub-basins, 1993-1995.
