# **HABITAT CONDITIONS**

### **Aquatic Community Classification**

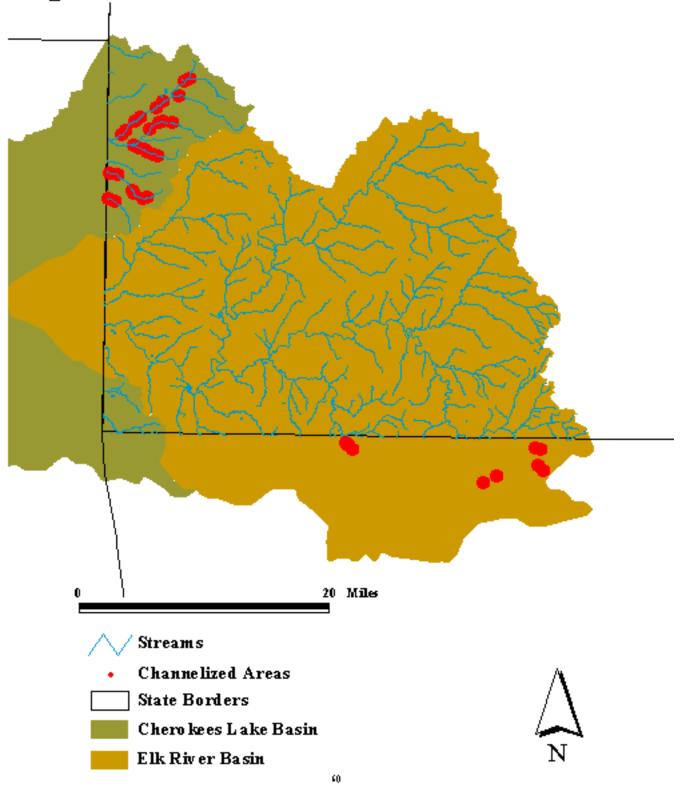
Figure 18. Channelization in the Elk River basin.

Channel alterations in the basin include modifications to urban stream courses, channelization associated with road and bridge construction, several small impoundments, channel modifications related to gravel removal, and efforts by individuals to control streambank erosion. Larger scale channelization seems to have been concentrated in the Lost Creek and Buffalo Creek drainages. Lost Creek and its tributaries above Seneca, Missouri, have been extensively channelized in an effort to control flooding. Another area where channelization was noticed on topographic maps was in the Big Sugar Creek sub-basin near Pea Ridge, Arkansas. Two other areas of noted channel disturbance are Little Sugar Creek at Bella Vista, Arkansas, and the Elk River along Highway 71 just south of Pineville, Missouri (Gordon 1980). Areas where channelization was apparent on topographic maps are shown in Figure 18. Instream commercial gravel mining operations are scattered throughout the basin. However, they seem to be more prevalent in the Big Sugar Creek and Little Sugar Creek sub-basins. There are several areas of small scale channel disturbance (probably gravel removal) presumably for purposes such as driveway and field road maintenance, beach/bank reshaping, and low water ford maintenance. The cumulative effect of these activities is not known.
