MISSOURI Natural Areas

2022
Volume 22, Number 1

Missouri’s Big River Systems

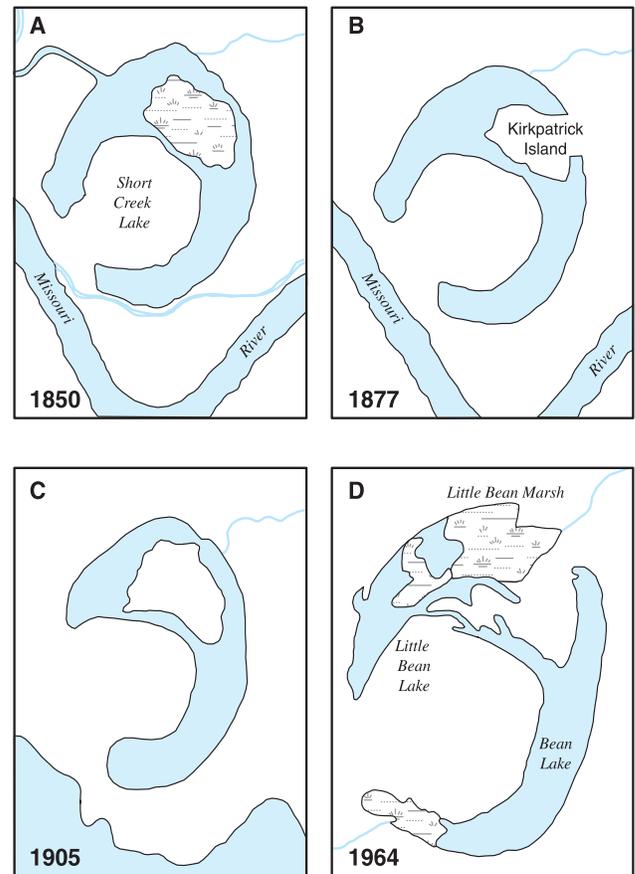
Historical evolution of Little Bean Marsh (Castner and LaPlante, 1992)

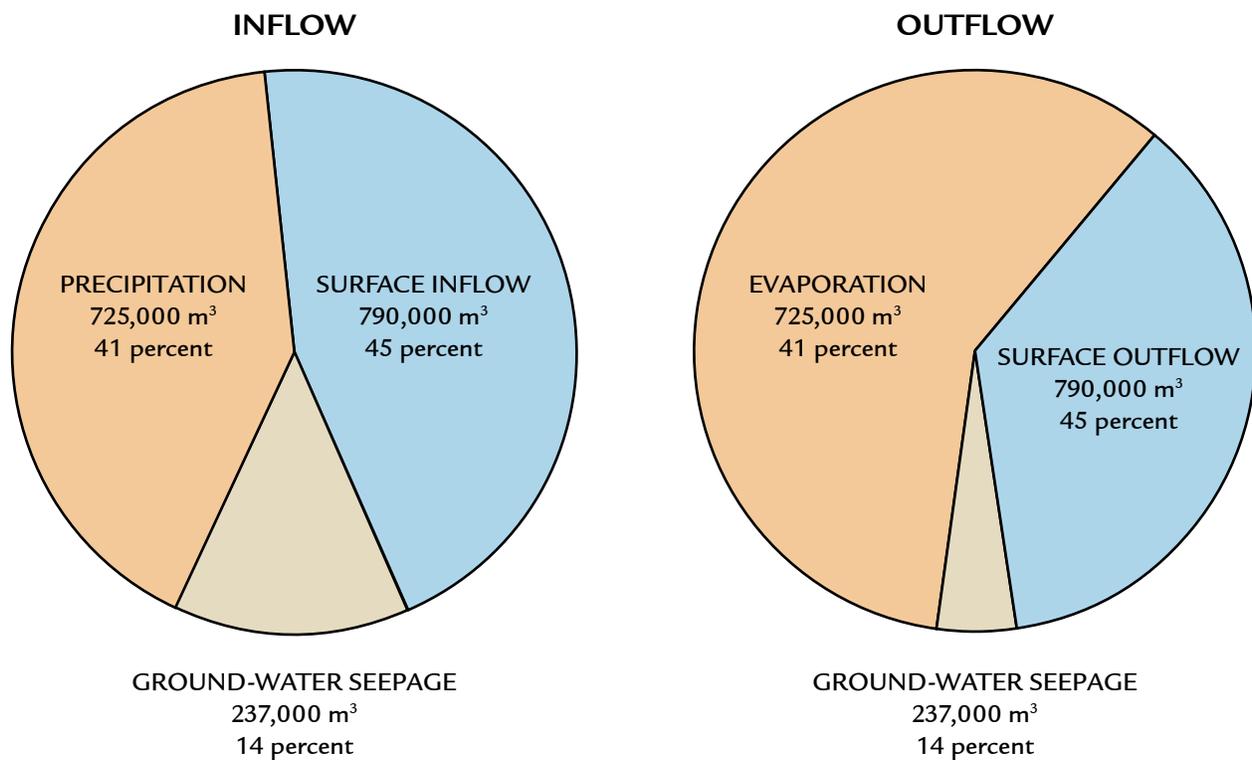
Inflow and outflow water budgets for Little Bean Marsh during 1997

More water was lost from the marsh through evapotranspiration (59 percent) than all other pathways combined. This characteristic partially is because of abundant macrophytes that can increase evapotranspiration above that lost from open-water surfaces. Surface outflow accounted for 36 percent and groundwater seepage accounted for only 5 percent of the losses. Long residence times and large evaporative losses allow Little Bean Marsh to perform the hydrologic functions of peak-flow attenuation and

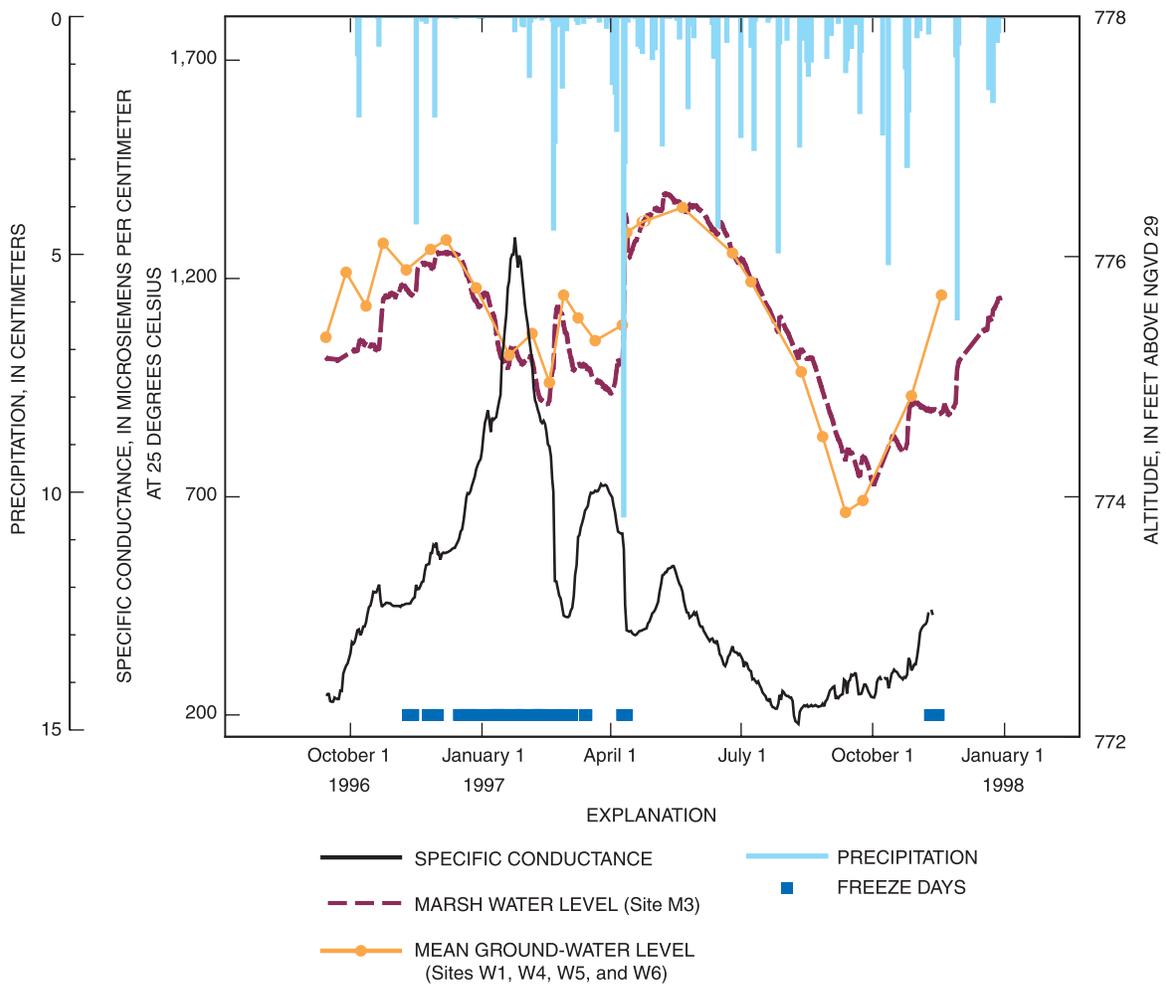
Specific conductance, marsh water level, mean ground-water level, precipitation, and days with mean air temperatures below 0 degrees Celsius at Little Bean Marsh

the marsh, ion exclusion during ice formation in the winter caused the greatest specific conductances during the entire monitoring period. This substantial increase in the concentration of all dissolved solutes could make wetlands more vulnerable to toxic contaminants in the winter than other surface water bodies.

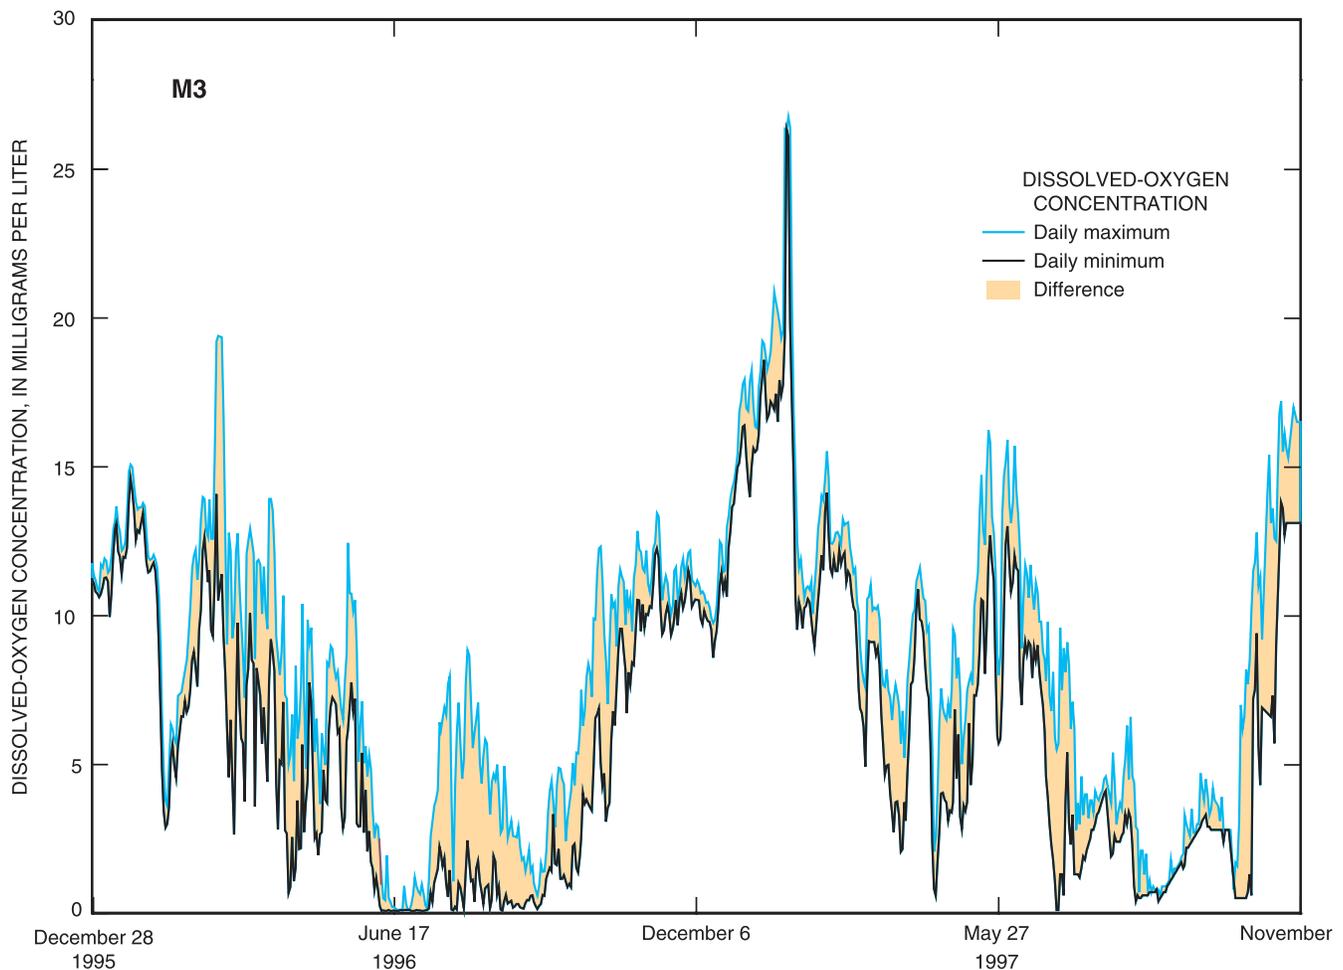
Daily maximum and minimum dissolved oxygen concentrations at site M3 in Little Bean Marsh.

Dissolved oxygen concentrations were less than 5 mg/L for 3 to 4 months in 1996 and 1997, and were near zero for about 1 month during the summers of both years. These periods of anoxia produce widespread reducing conditions that inhibit nitrification, enhance denitrification, and cause iron reduction and phosphorus (P) release. The largest diel changes were about 5 mg/L that often occurred during periods of low dissolved

oxygen concentrations. Dissolved oxygen concentrations were significantly greater at open water sites than at sites with emergent vegetation because of shading and decomposition of a large amount of detritus. These extended periods of anoxia during the summer undoubtedly limit the habitat for certain fish and other fauna that have not adapted to low oxygen conditions and have no refuge in a shallow marsh.

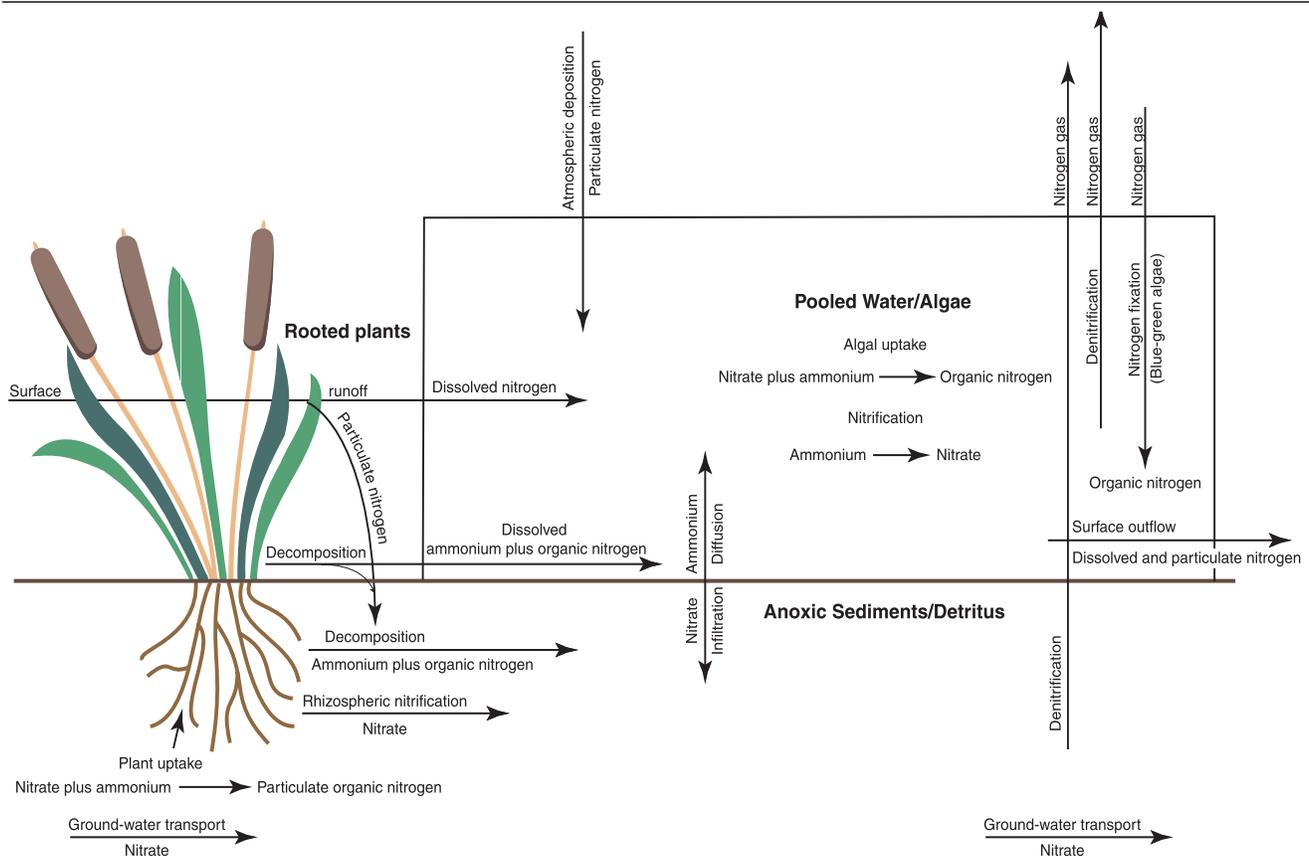
Conceptual compartments and dominant processes involving nitrogen in Little Bean Marsh.

Results of denitrification experiments indicate that denitrification rates were limited by NO_3 in the water column. Consequently, decomposition and nitrification of ammonium (NH_4) and organic N are the rate-limiting steps of N removal in Little Bean Marsh. Conditions for high rates of denitrification were almost ideal in the bottom sediments of the marsh. The dominant macrophytes in the marsh were river bulrush and cattails; both have oxidizing rhizospheres around their roots. These rhizospheres greatly increase rates of the rate-limiting decomposition and nitrification processes over rates occurring in open-water areas where all NO_3 must diffuse from the water column through the sediment/water interface, as opposed to being created in the sediments. The NO_3 limitation on rates of denitrification also indicate that Little Bean Marsh has a large unused capacity for N removal.

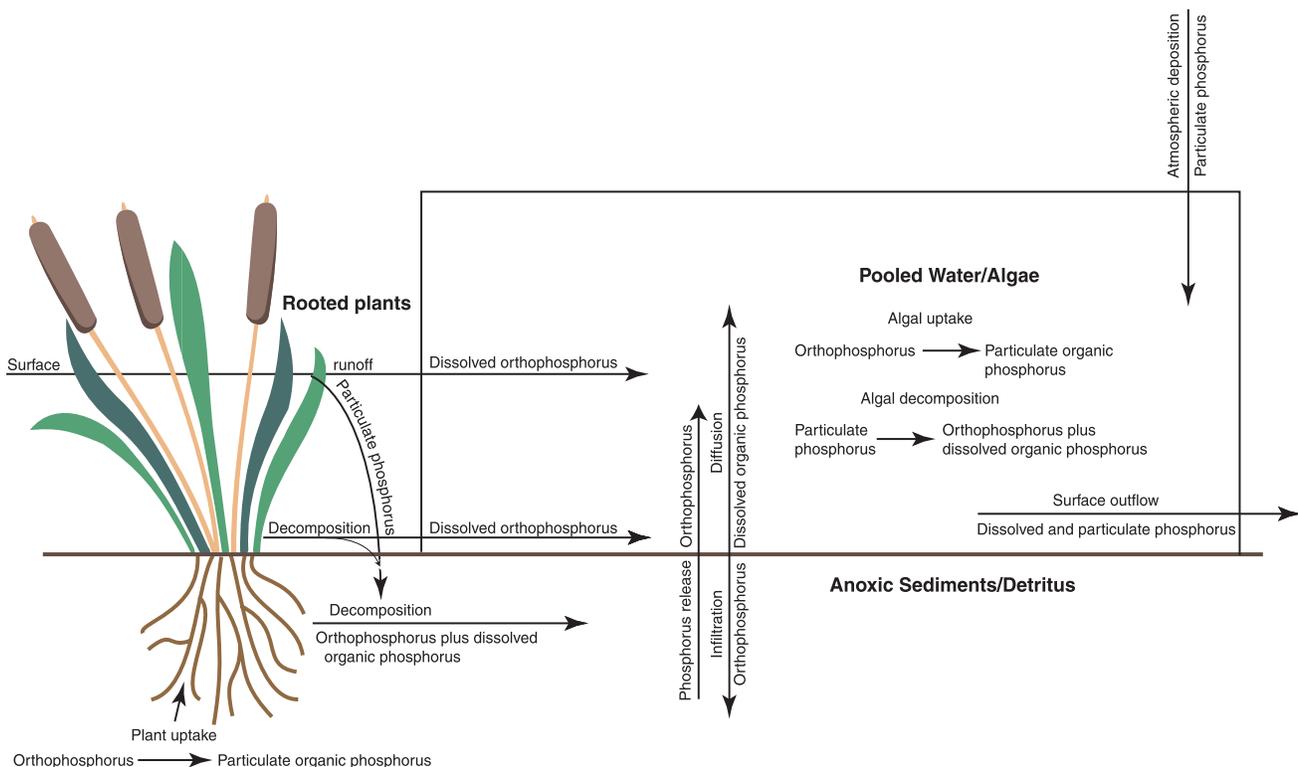
Conceptual compartments and dominant processes involving phosphorus in Little Bean Marsh.

face outflows. P contributions from atmospheric deposition to the marsh are small compared to the 53 kg of P in surface outflows in 1997. Low concentrations of P in ground water caused ground water to be a small source of P to Little Bean Marsh as well. The long hydraulic residence time of the marsh and large contributions of iron from ground water (that provide many sorption sites for P) make the marsh an effective sediment and P trap. These characteristics, plus the large long-term retention of P by the macrophytes after senescence, make burial of P a substantial sink of P in Little Bean Marsh.

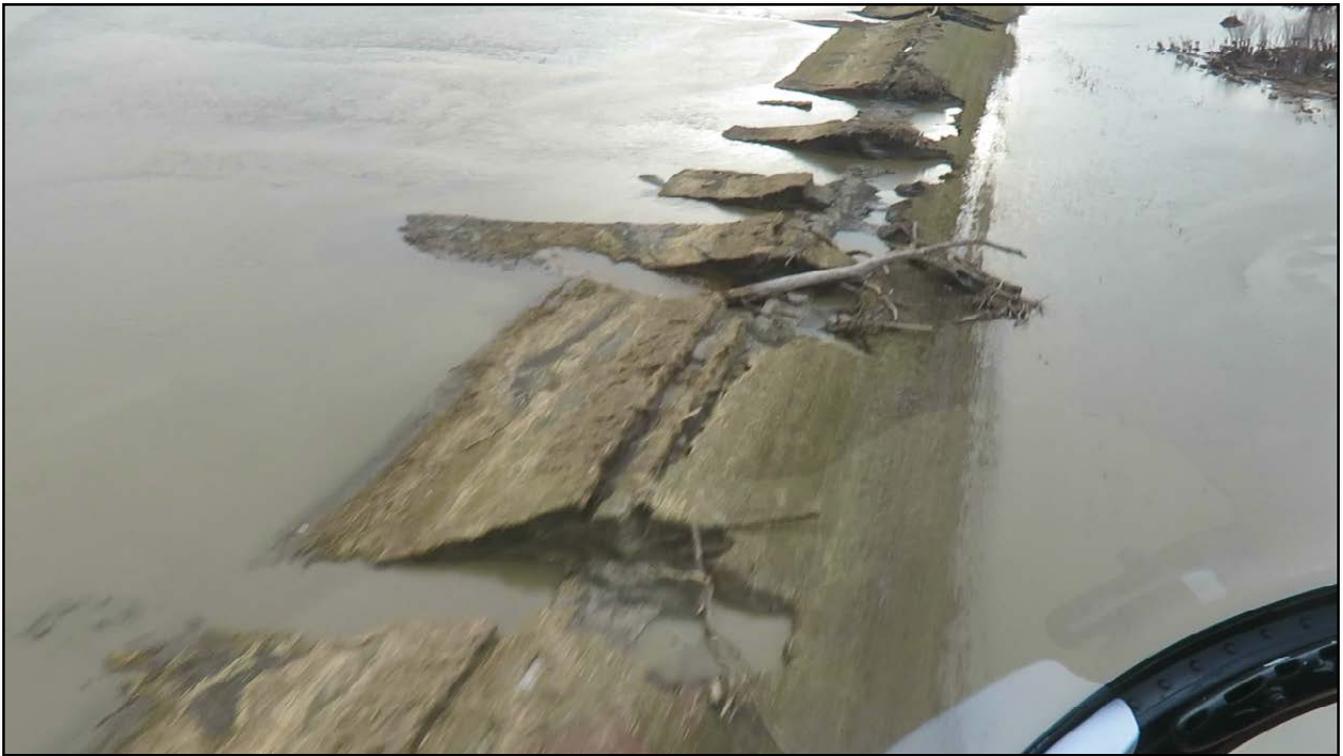
Damage on the L536 showing breaches and water flowing through them

The river flows overtopped the L-536 levee, initiating erosion of the levee crest, ramps, landward side slope, and the levee/berm toe. Flood damages caused five breaches (four inlet, one outlet) and additional reaches of critical section loss (i.e., “partial breaches”). The levee sponsor, Atchison County Levee District No. 1 (ACLD) provided a letter to the U.S. Army Corps of En-

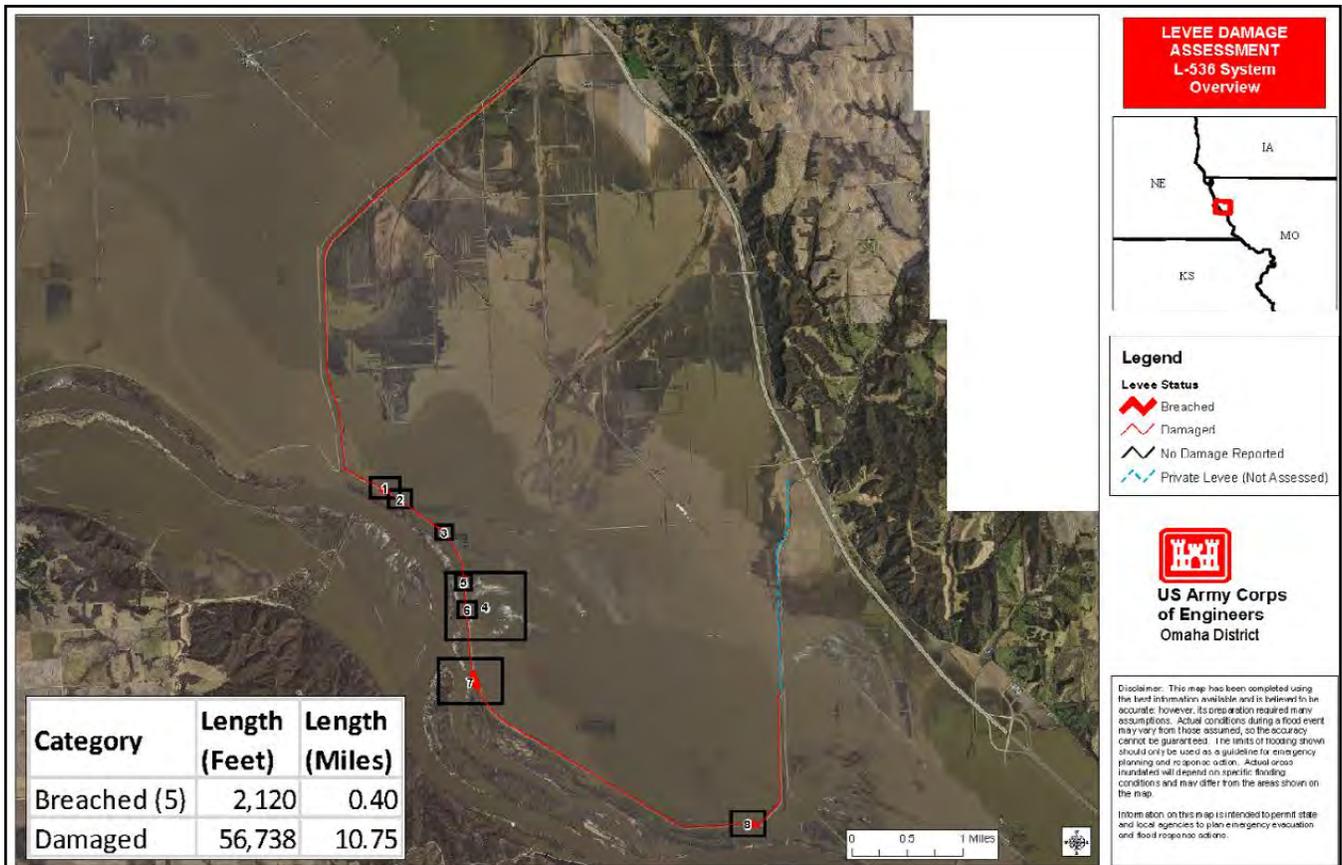
Figure 1. Full L-536 levee system damage map

The Rock Creek tieback levee on the upstream end of the L-536 levee system was minimally damaged compared to the Missouri River reach and downstream Mill Creek tieback. Figure 1 (below) and Figure 2 (following page) present 2019 aerial imagery of the damaged levee with breach locations identified. Through 2019 and periodically in 2020, the system continued to be partially inundated with the majority of inflow through Breach F. The majority of the outflow exited through a breach in the Mill Creek Right Bank levee to the north of the L-536 levee Mill Creek tie-back.

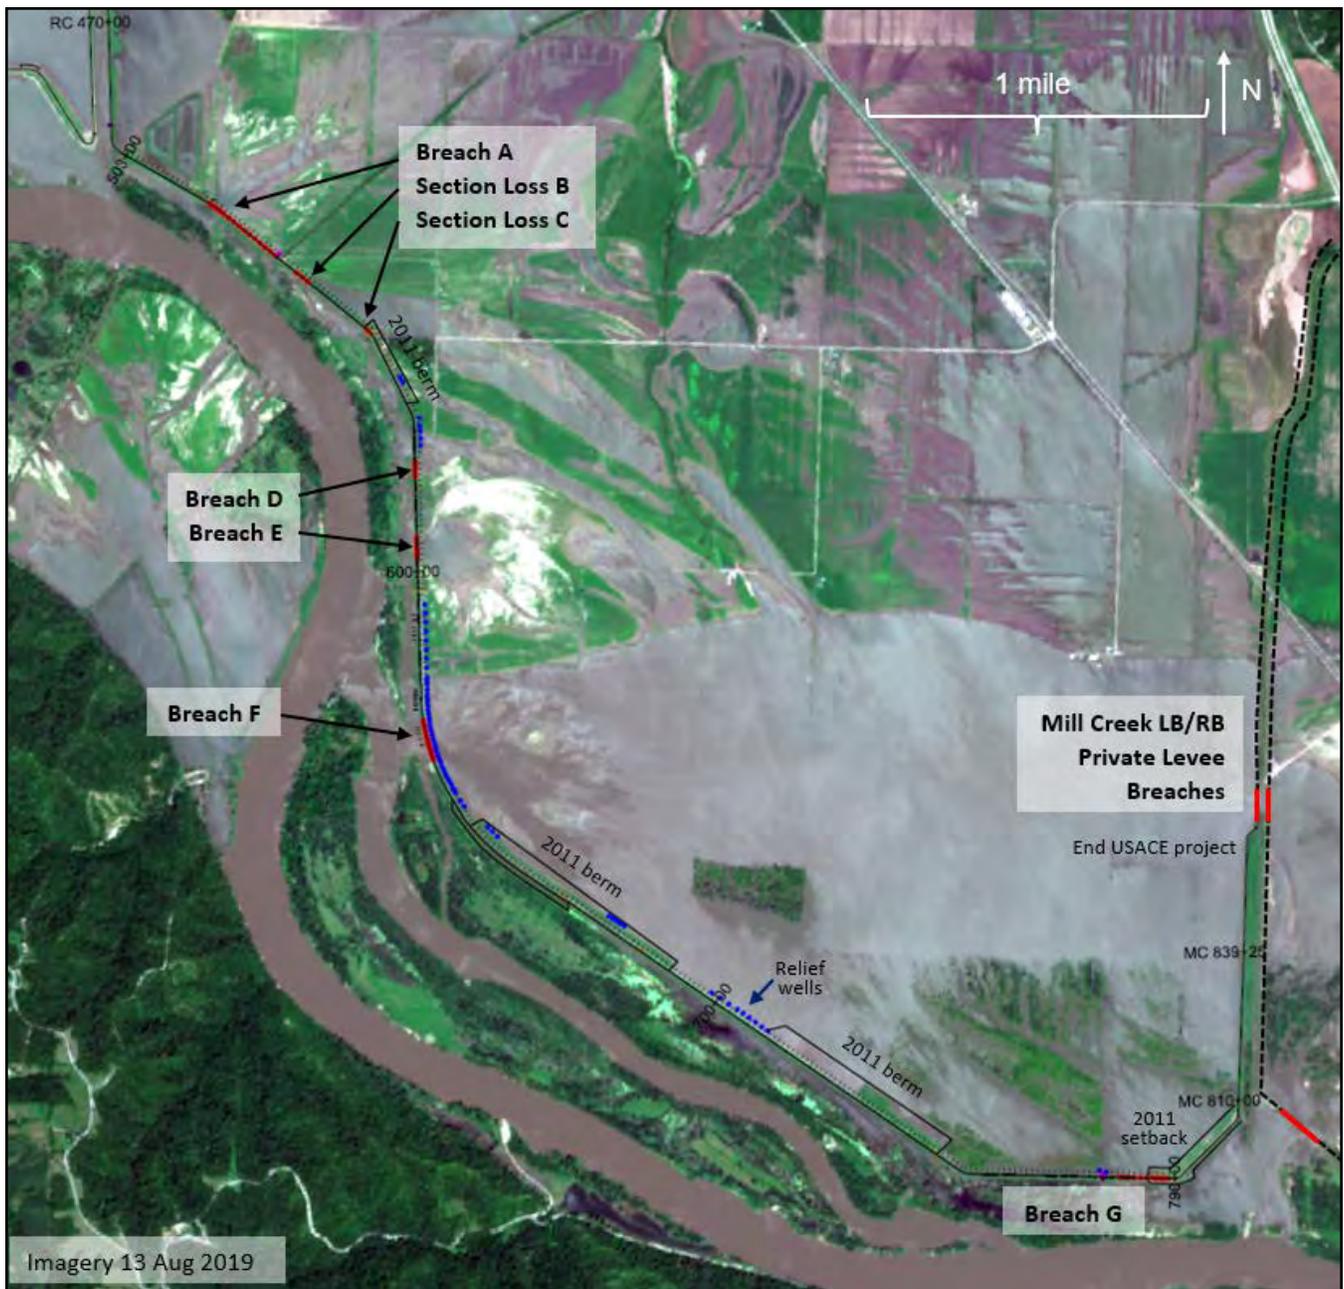
Figure 2. L-536 breach location map

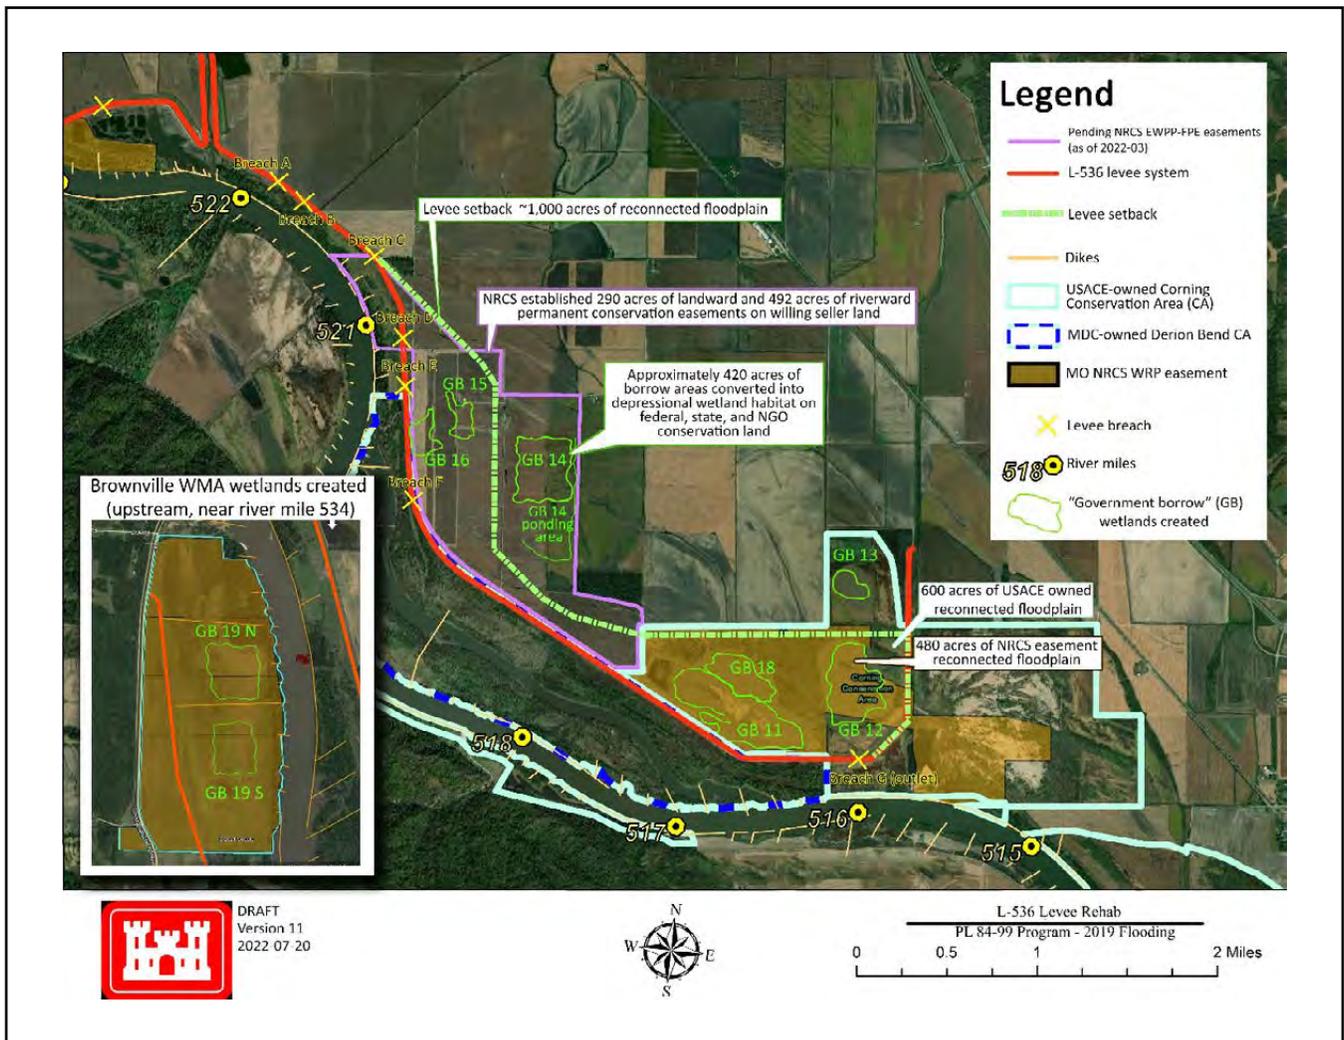
Figure 4. L-536 levee setback project and environmental features

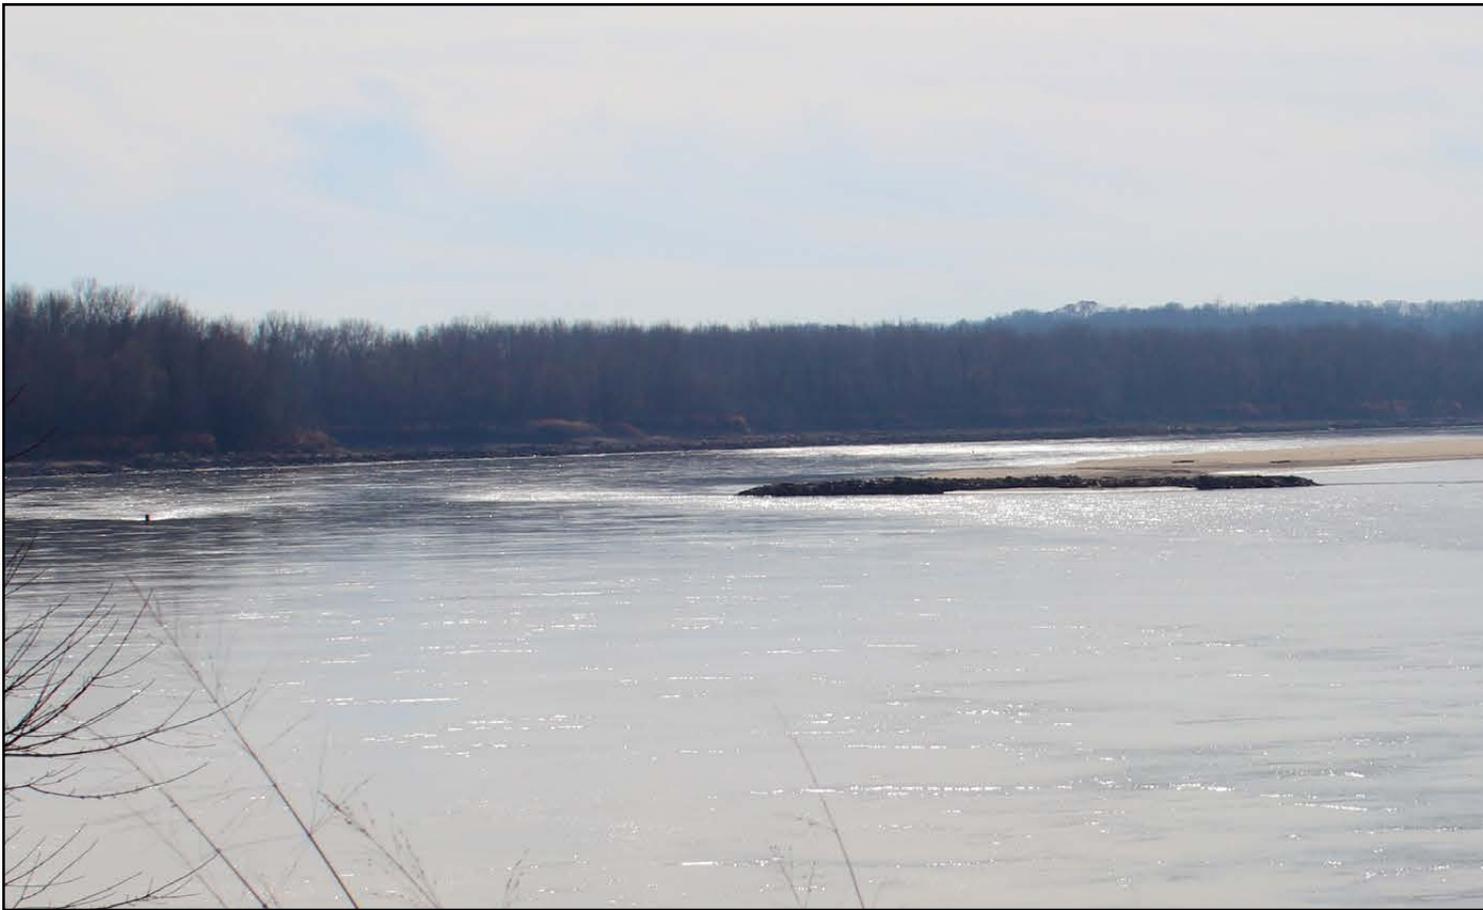
A control structure directs flow and sediment from the main channel of the Missouri River at Searcy's Bend. This structure creates a side channel and shallow water habitat at Airplane Island next to the Overton Bottoms South Unit of the Big Muddy National Fish and Wildlife Refuge. This structure built as part of the Interception-rearing-complex Habitat Project.

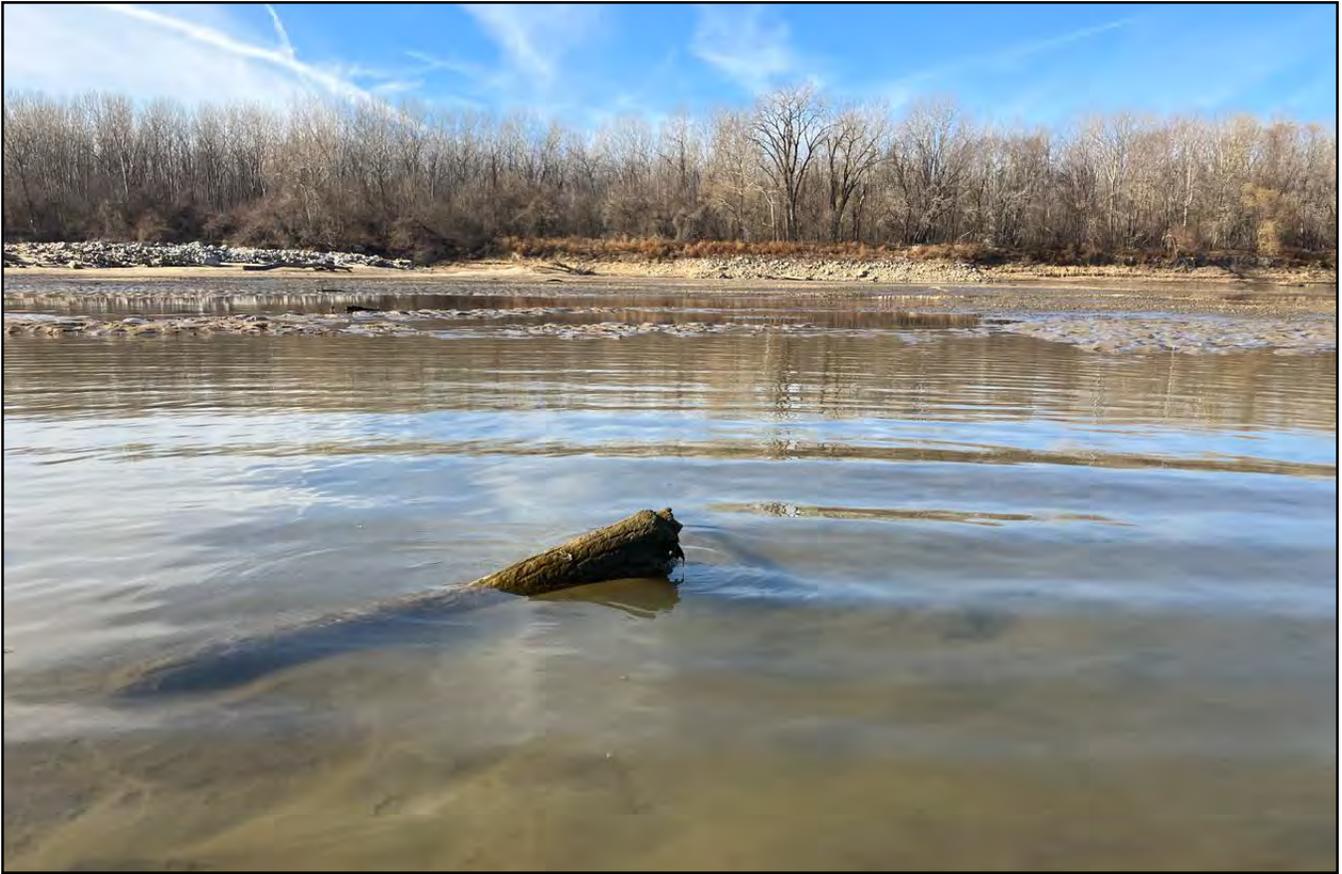
Shallow water habitat at Airplane Island. Sediment and debris drop out of the channel at this location because of rock control structures (seen in background) placed by the US Army Corps of Engineers as part of the Interception-rearing-complex habitat project. Low winter flows produce clear waters in the now sediment-starved Missouri River.

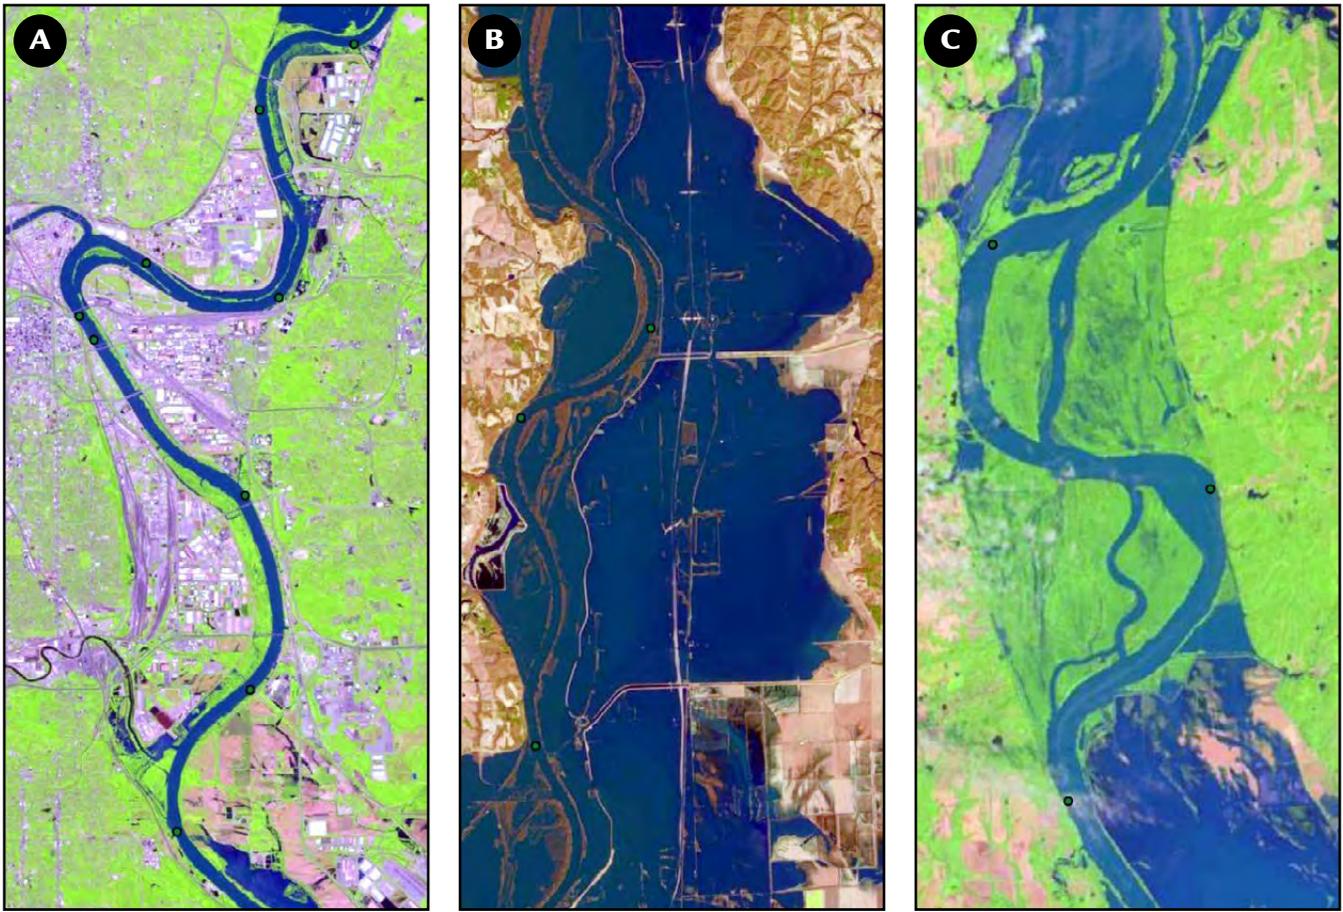
Figure 1. Examples from the 2019 flood on the Lower Missouri River showing three types of resilience. A. Kansas City, Missouri, area with high engineering resilience. B. Lisbon Bottom and Jameson Island units of the Big Muddy Fish and Wildlife Refuge near Arrow Rock, Missouri, area with high ecological resilience. C. Agricultural land near Bartlett, Iowa, showing lack of resilience in areas with overtopped levees, flooded agricultural fields, and flooded transportation infrastructure.

The ecological literature differentiates between engineering resilience and ecological resilience (Gunderson, 2000). Engineering resilience minimizes damages to floodplains and adjacent communities by containing floods with levees or floodwalls (Figure 1). However, when engineered structures fail to contain a flood, damages can be extensive. In addition to inundation damages to structures or crops, discharge of floodwaters through levee breaks

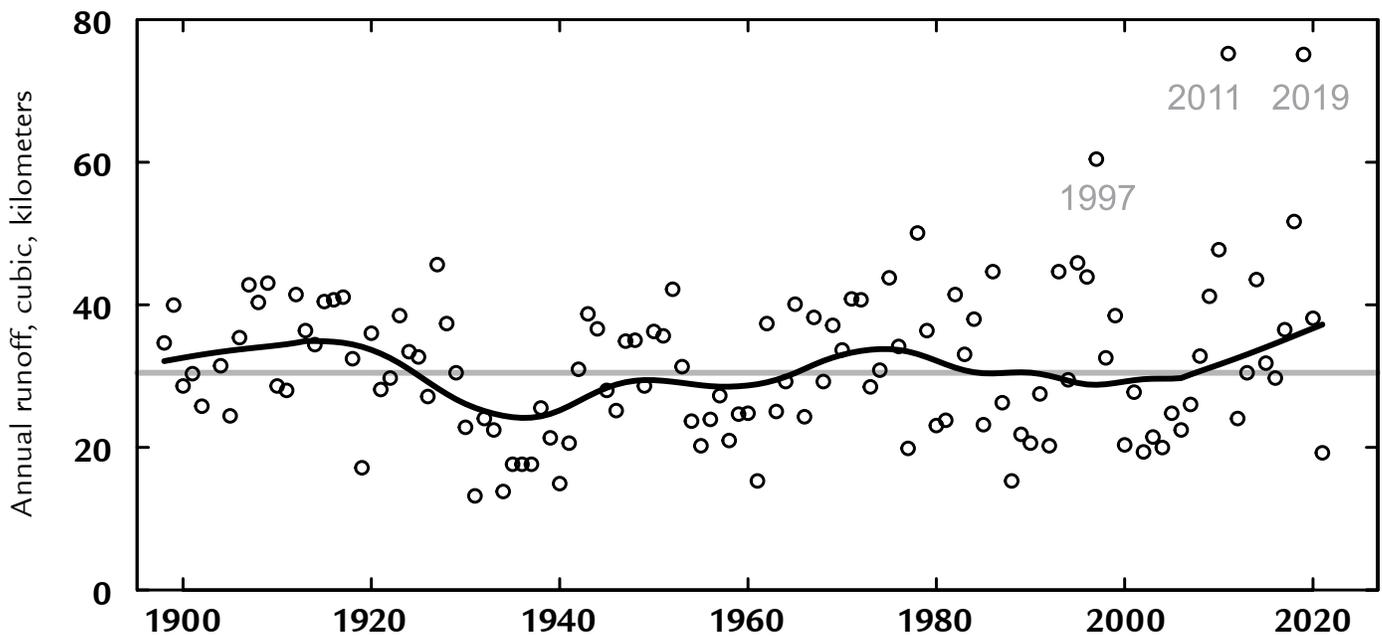
Figure 3a. Annual runoff upstream of indicated streamgage in cubic kilometers. The black line is a locally weighted regression (LOWESS) smoothing function using a span of 25% of the data. The gray line is the median of the runoff for the indicated period of record. Runoff into the Missouri River mainstem reservoir system at Gavins Point Dam, South Dakota, 1898 - 2020; source: US Army Corps of Engineers, Missouri River Water Management.

Non-stationarity is a term used by statistical hydroclimatologists to describe systems with temporal trends. Whereas all time series of hydrologic and climatic data show great variability within- and among-years, non-stationarity is identified when the average conditions are changing substantially over time. Non-stationarity has important implications for water resources engineering because the design of reservoirs, levees, flood walls, and other water features is dependent on calculations of how big and how often large flows occur. With the realization that climate change is affecting time series of hydroclimatic events, some scientists declared that “stationarity is dead,” with the implication that designs based on past data are no longer viable for long-term engineering resilience (Milly and others, 2008).
