# *Niangua River*

## **INVENTORY AND ASSESSMENT**

### **Niangua River Watershed Inventory and Assessment**

**Missouri Department of Conservation**

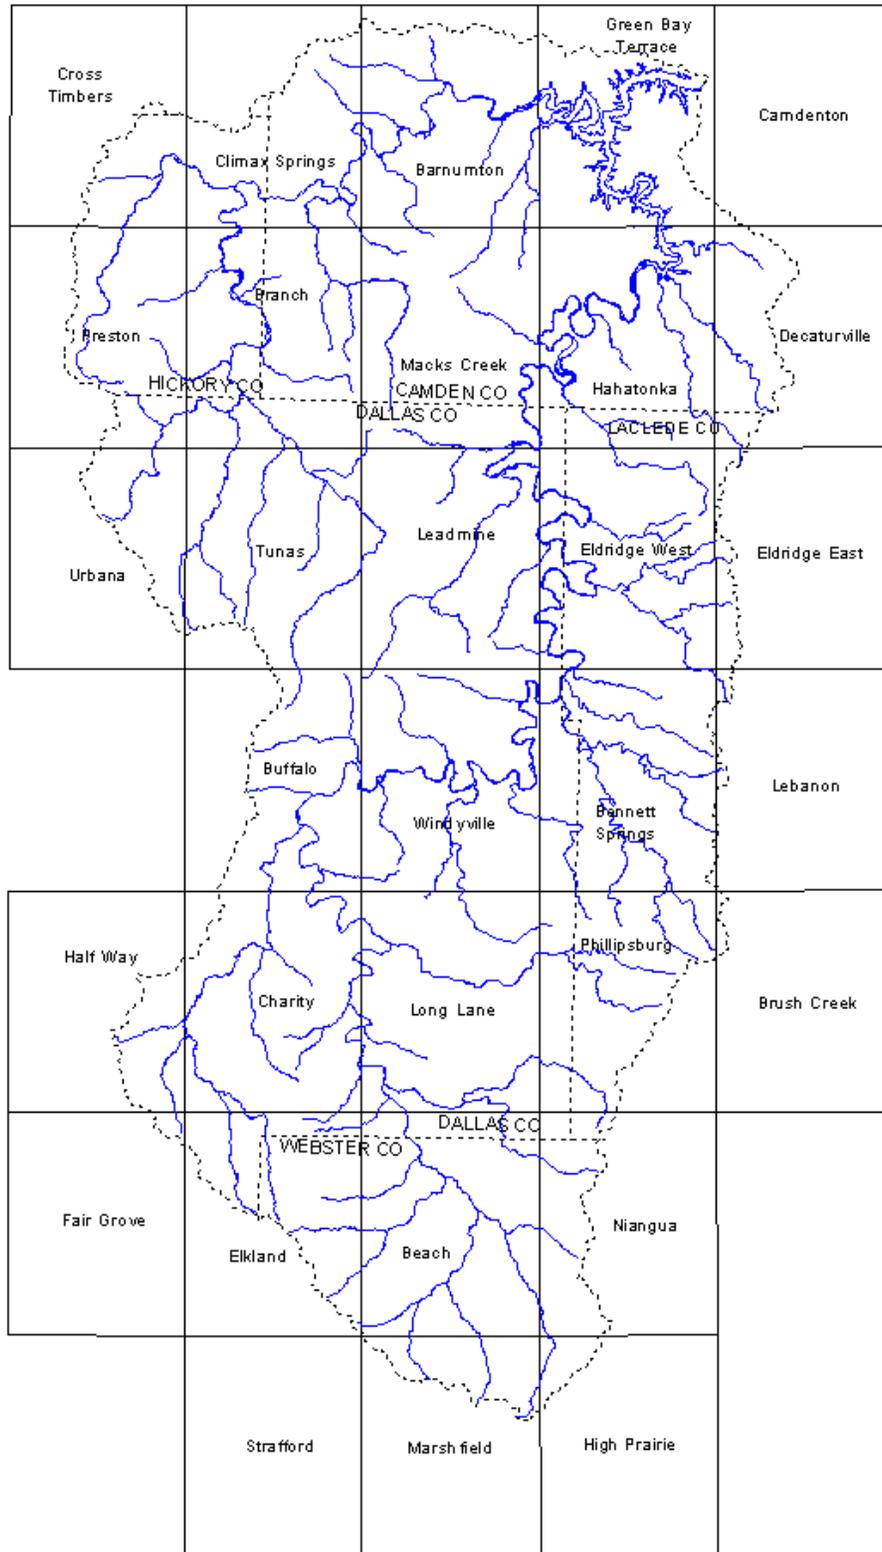
**Figure 4. 7.5 topographic maps that include the Niangua Watershed.**

Stream gradients were determined for all third order and greater streams from the 7.5 minute topographic maps shown in Figure 4 and a table of elevations and average gradients is presented in Appendix C. Gradient plots were also created, but they are not included in this document. The average gradient of the Lower Niangua River is 3.9 feet per mile, the Upper Niangua River is 5.4 feet per mile, and the Little Niangua River is 9.4 feet per mile.

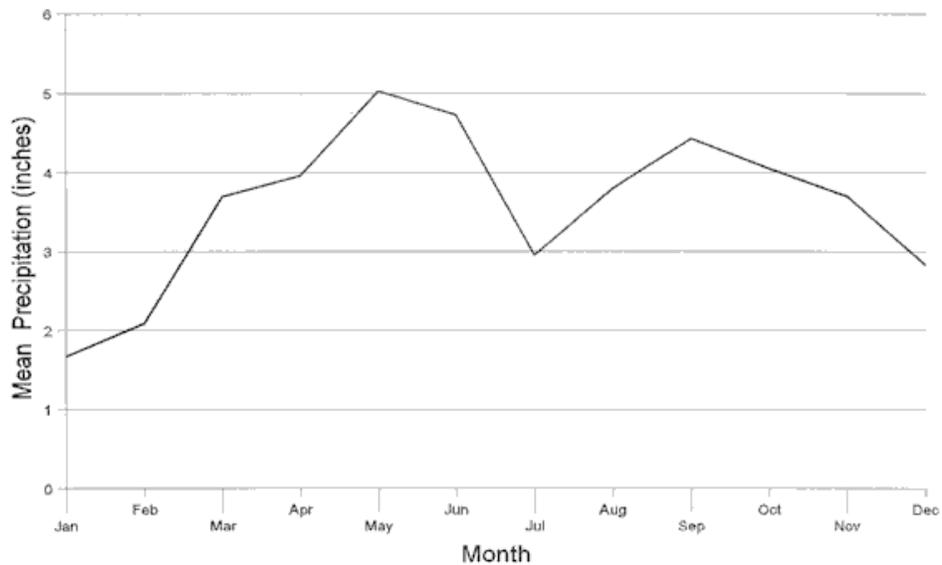
**Figure 07. Mean monthly precipitation at Buffalo, Missouri between 1930 and 1995.**

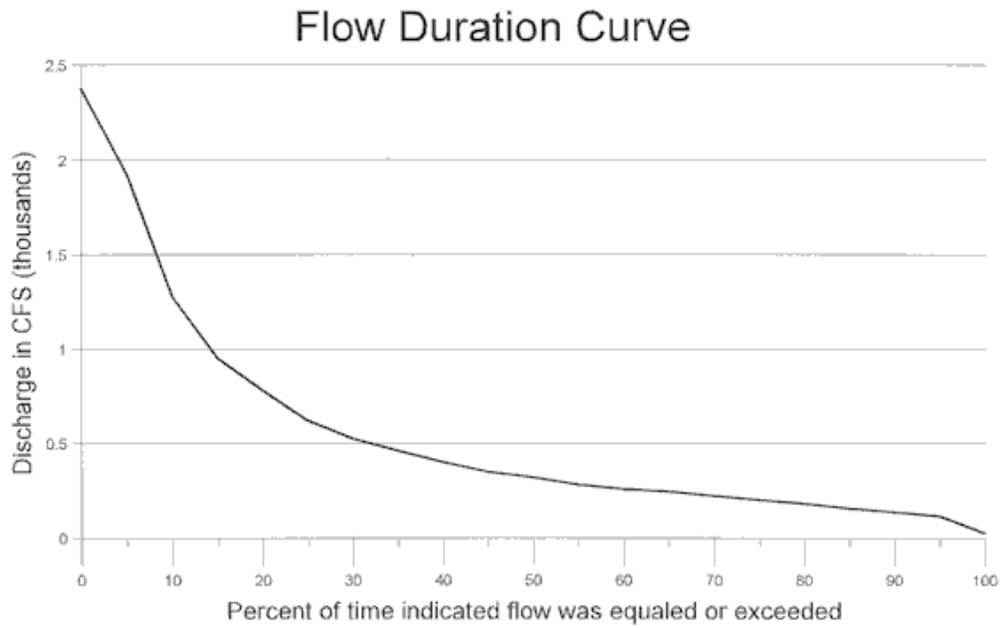
**Figure 09. Flow duration curve for the Niangua River near Decaturville (G024).**

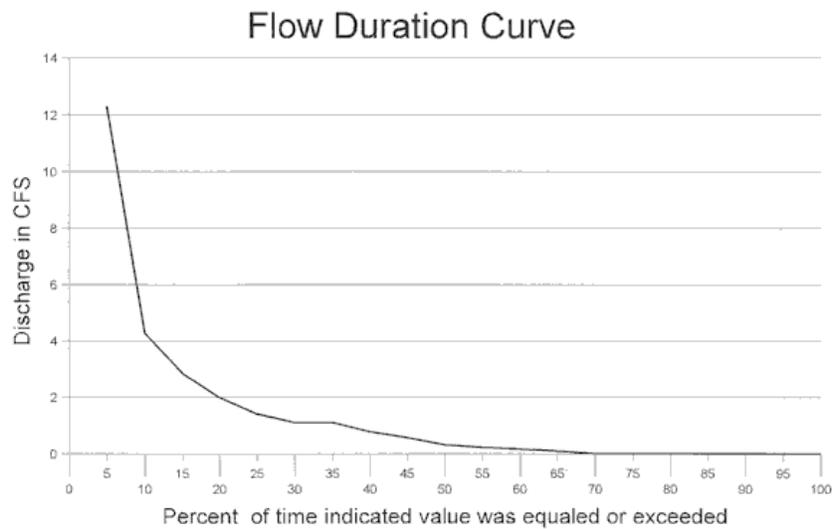
**Figure 10. Flow duration curve for Starks Creek near Preston (G024).**
